Cardiff Parkway Developments Ltd Cardiff Hendre Lakes 2017 Riparian Mammal Survey Report

Environmental Statement Appendix 7.11

Issue | 11 August 2018

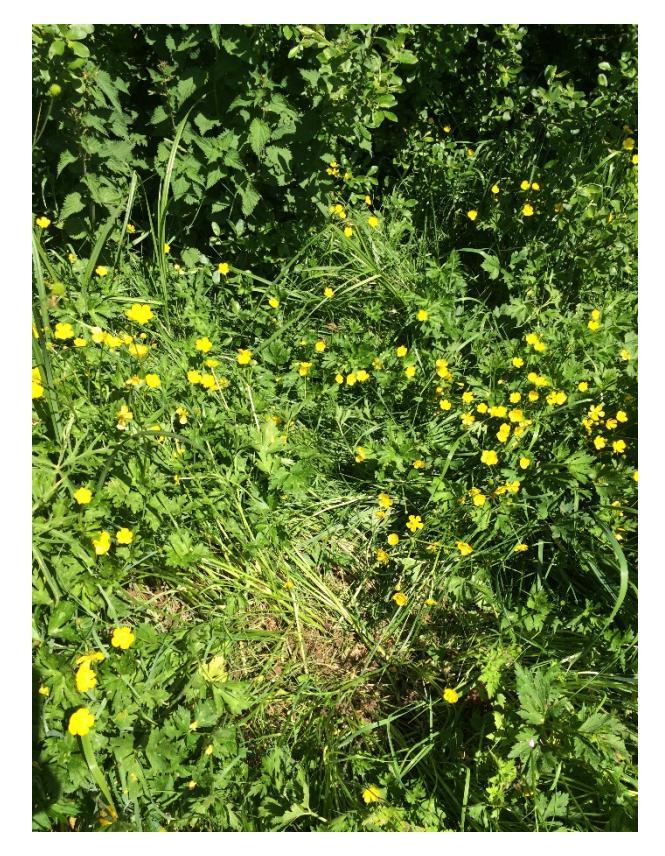
Photograph 1 Potential Otter Couch

No field signs for otter were discovered during the dedicated surveys undertaken in 2017. However, a potential otter couch (shown in Photograph 1 and on Figure 2) was recorded in the margin of an arable field alongside water body 4 during other ecological surveys.
