Cardiff Hendre Lakes

2019 Riparian Mammals Survey Report

Environmental Statement Appendix 7.12

Issue | 21 March 2020

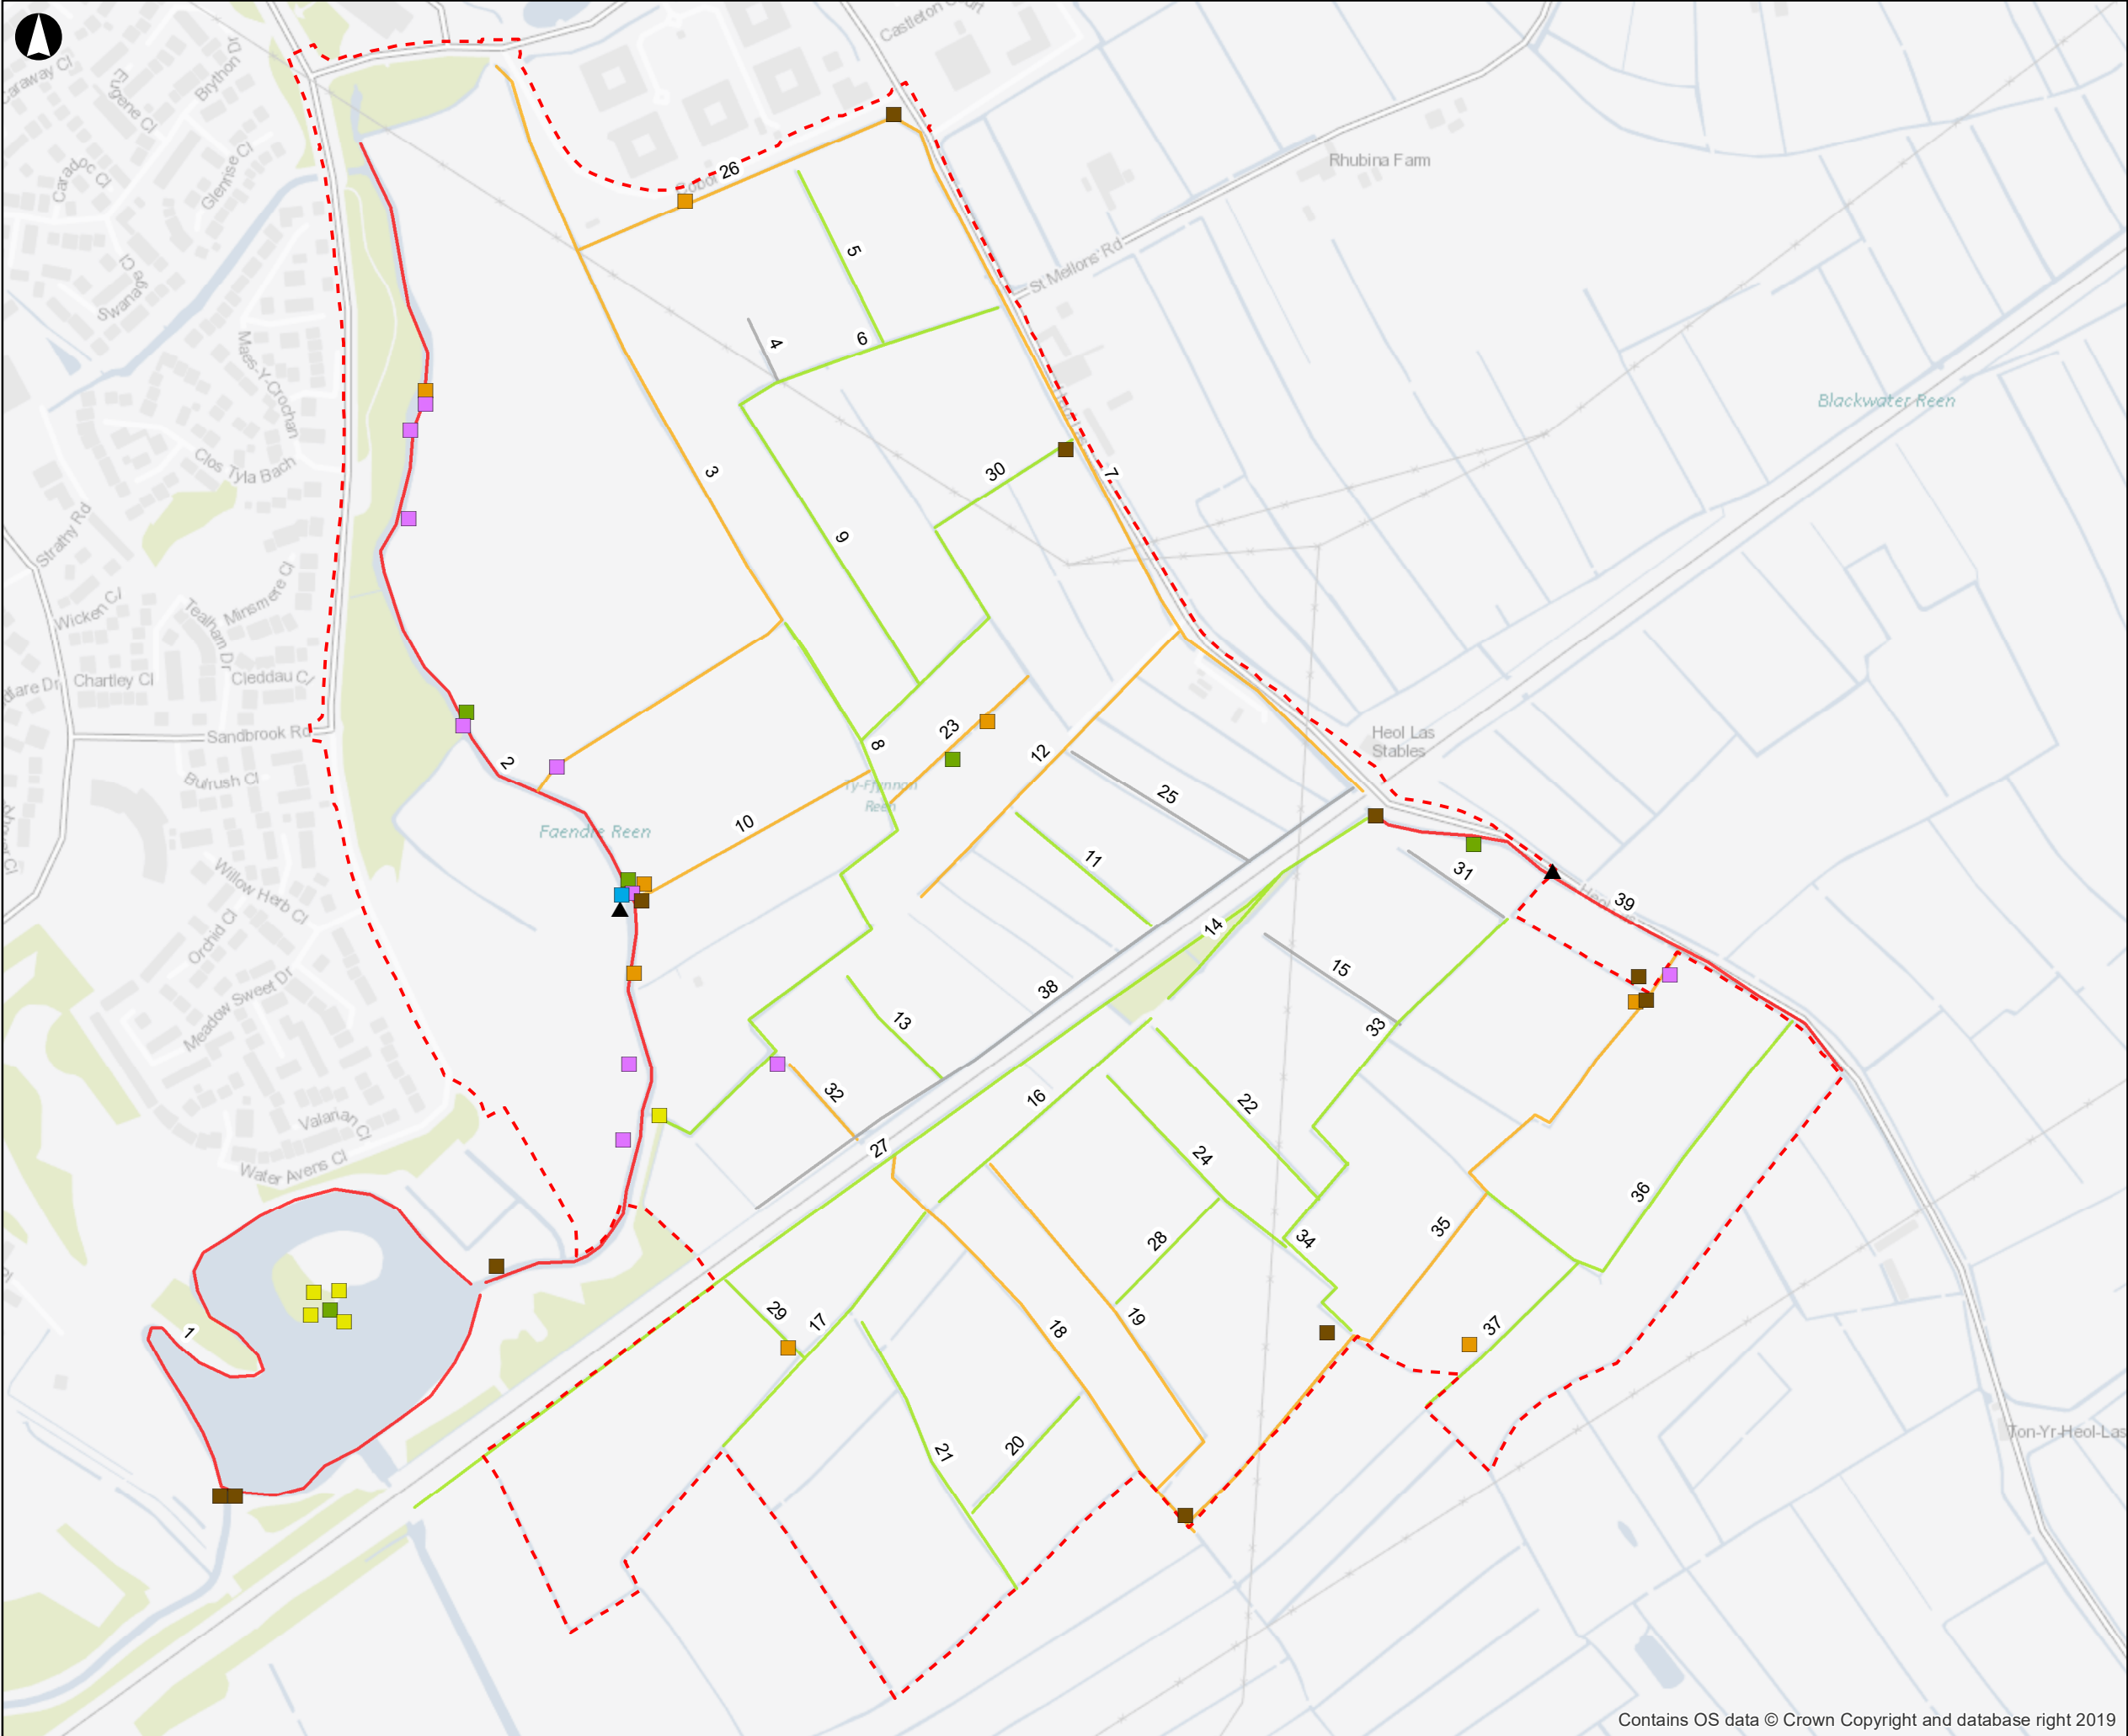
Figure 2: Otter survey results

Numerous signs of otter were recorded across the site during both the early and late 2019 survey visits. Spraints were identified at seven waterbodies (Waterbodies 1, 2, 26, 30, 34, 35, and 39), footprints were recorded on one

occasion (waterbody 2), laying up sites were identified at four waterbodies (Waterbodies 1, 2, 23, and 39) and slides were identified at three waterbodies (Waterbodies 2, 3, and 8). Feeding remains in the form of freshwater mussel and/or snail shells were identified at two waterbodies (Waterbodies 1 and 8). No holts or couches were identified at any waterbody during any survey visit.

More details of the otter presence / likely absence survey results can be found in Table 3 within Appendix B1.2, with results shown on Figure 2.

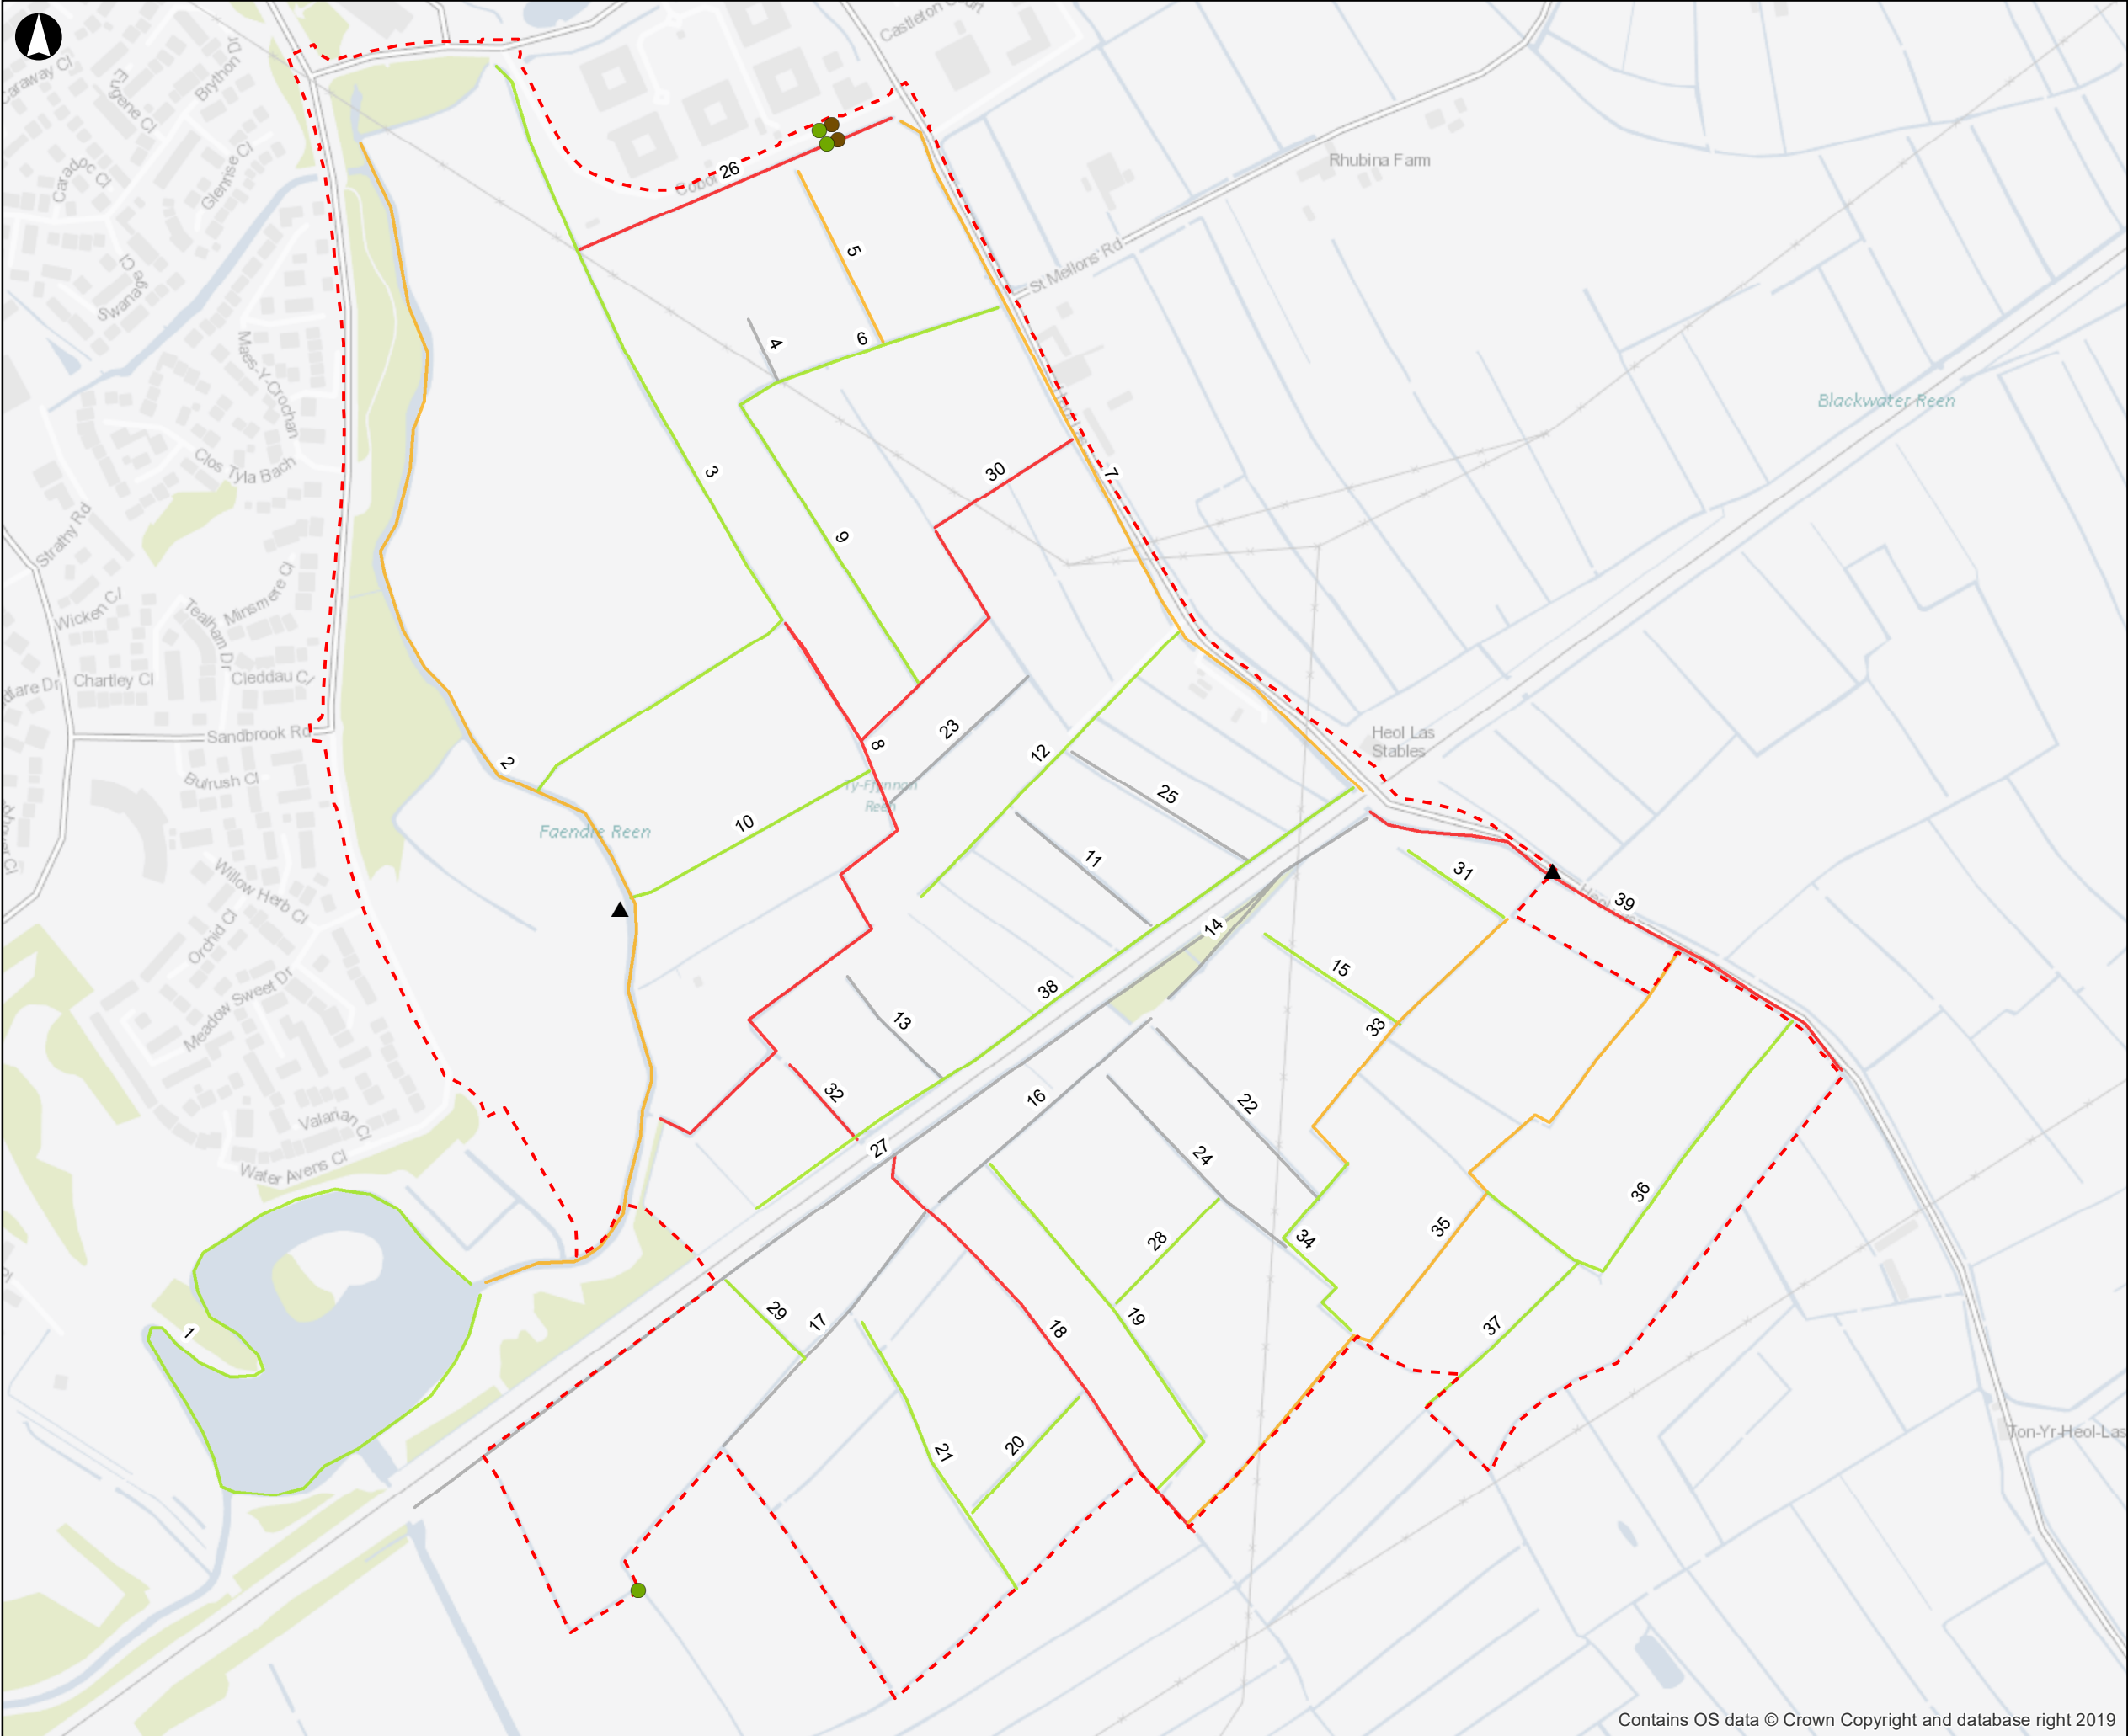
Figure 3: Water vole survey results

Six waterbodies of high suitability to support water vole were recorded within the survey area: Waterbodies 8, 18, 26, 30, 32 and 39. All of these are Main Reens managed by Natural Resources Wales, and therefore subject to regular management of the banks.

The suitability of waterbodies to support water vole are shown on Figure 3, with further details given in Table 2 within Appendix B1.1.

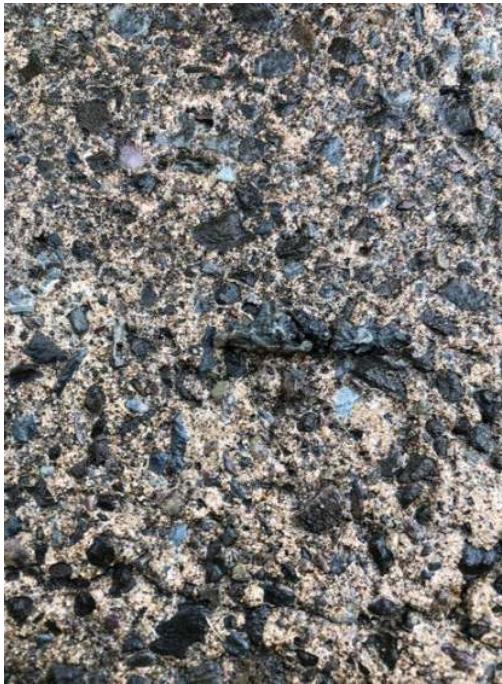
Photograph 1: One of multiple spraints identified on the concrete sluice structures around waterbody 1

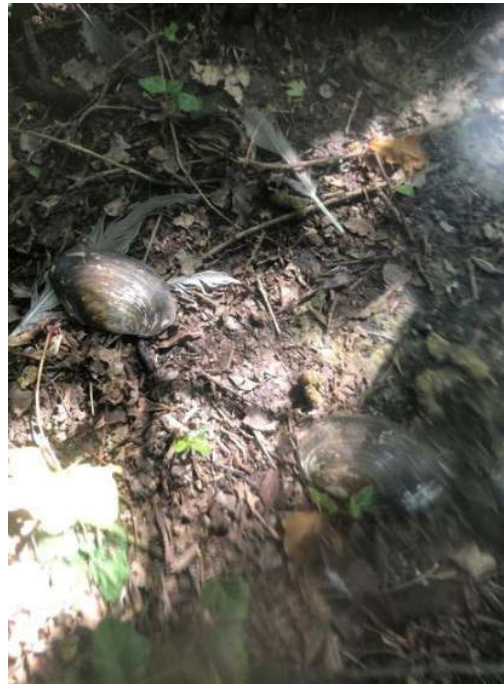
Photograph 2: Otter feeding remains on waterbody 1 island

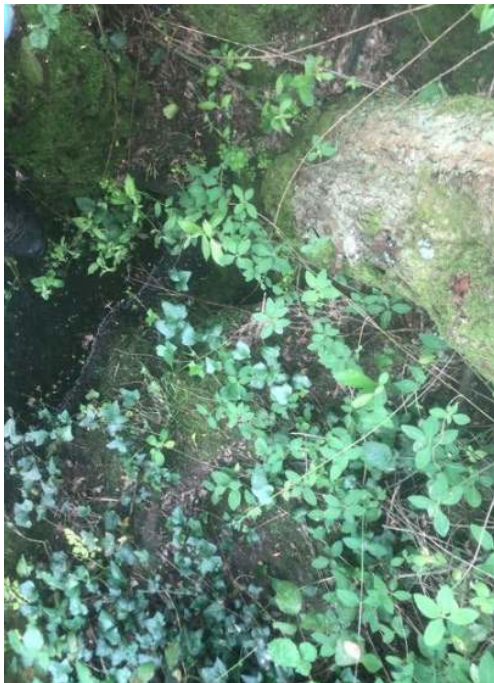
Photograph 3: Potential otter resting spot along waterbody 2

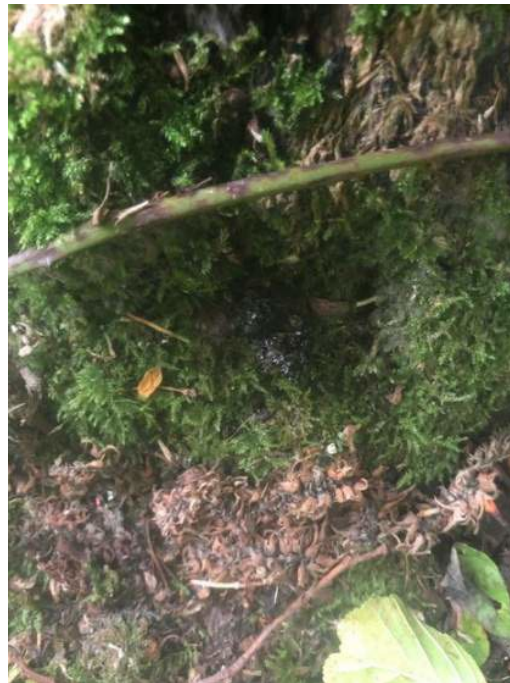
Photograph 4: Otter spraint on willow branch adjacent to mammal pathway into water at waterbody 2

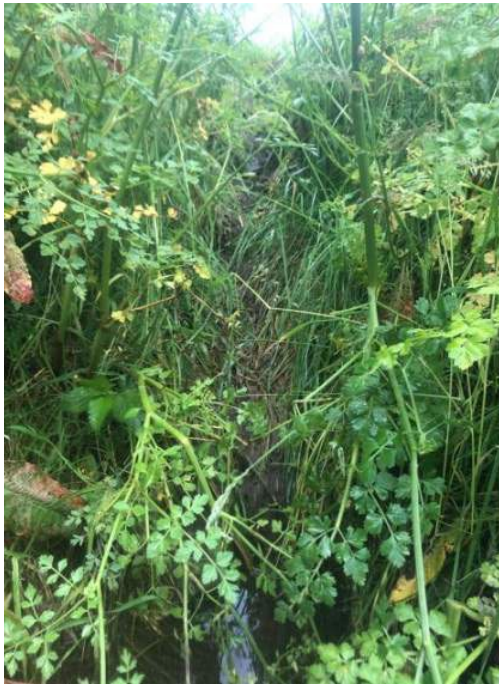
Photograph 5: One of multiple otter slides into water of waterbody 2

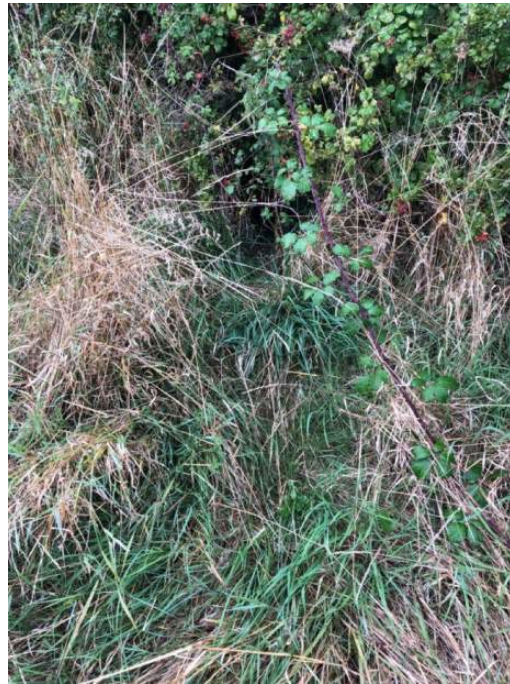
Photograph 6: Potential otter slide into water of waterbody 3

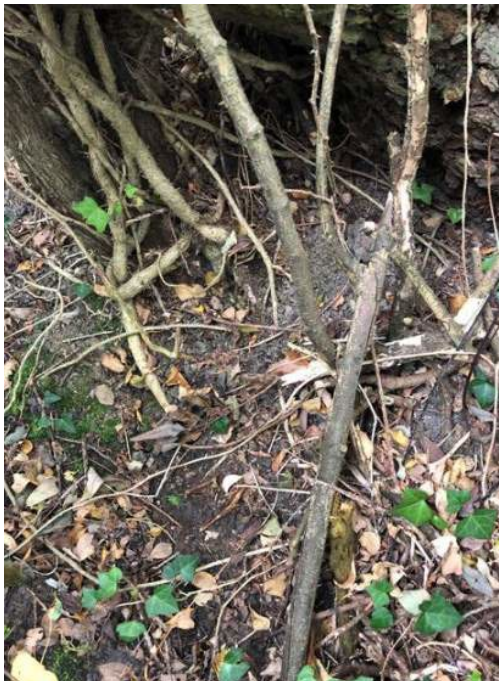
Photograph 7: Potential otter laying up site by waterbody 23

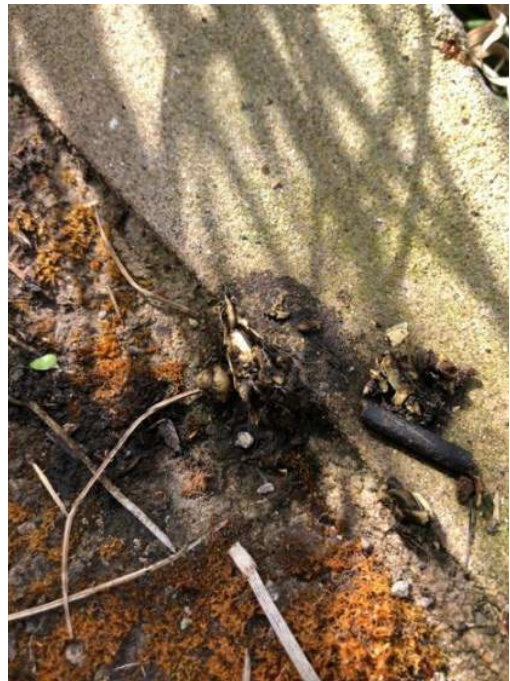
Photograph 8: Otter spraint on waterbody 26

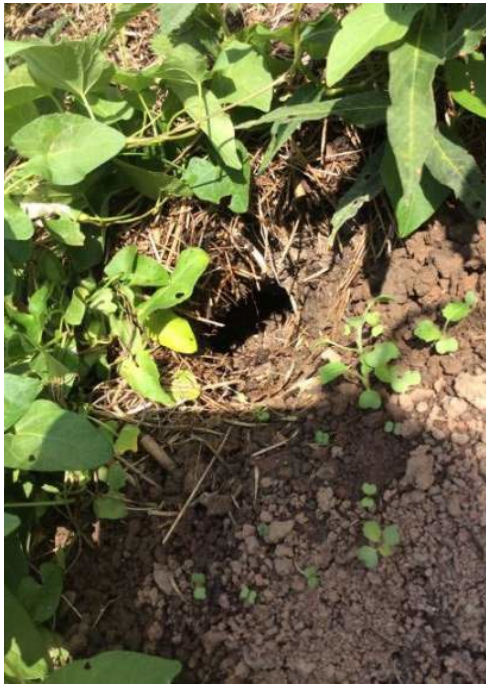
Photograph 9: Water vole burrow in bank slope of waterbody 26

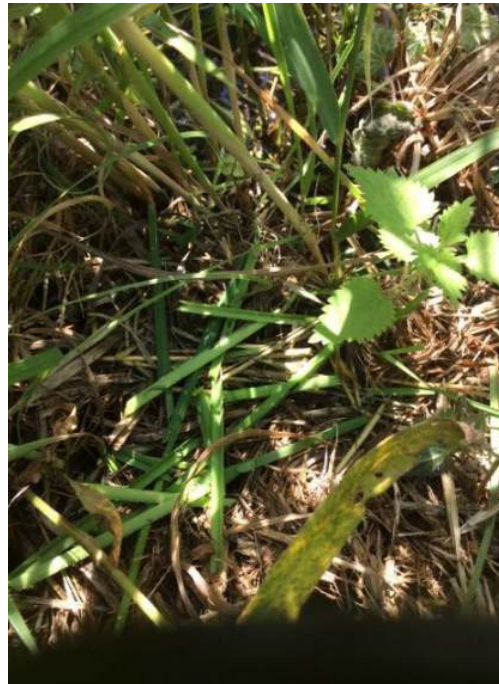
Photograph 10: One of multiple fresh water vole feeding stations identified along waterbody 26

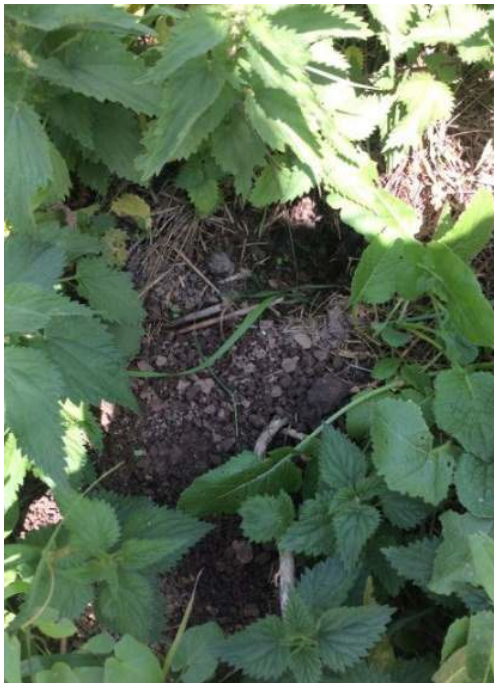
Photograph 11: Water vole burrow with fresh feeding remains on waterbody 26

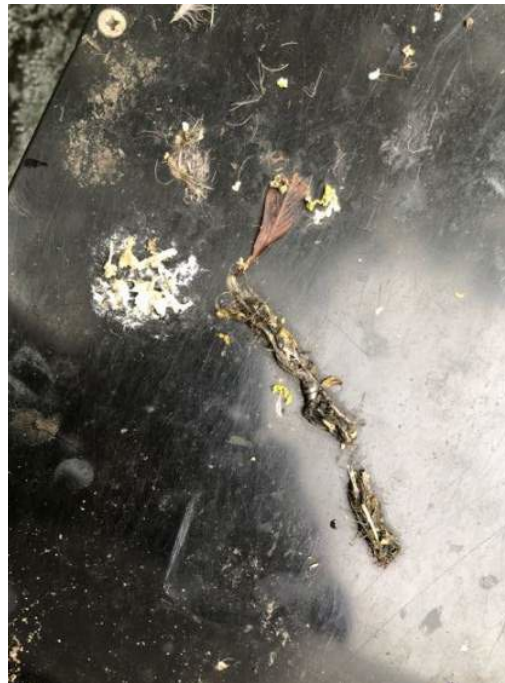
Photograph 12: One of several spraints present on sluice structure of waterbody 35

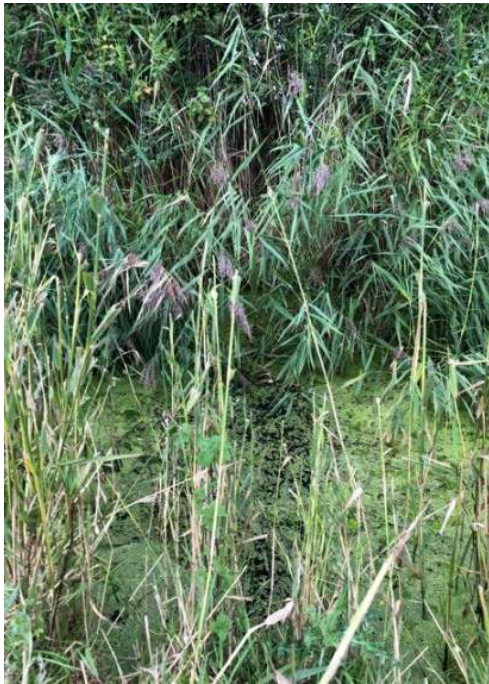
Photograph 13: Pathway through duckweed and through hedgerow of northern bank on waterbody 35

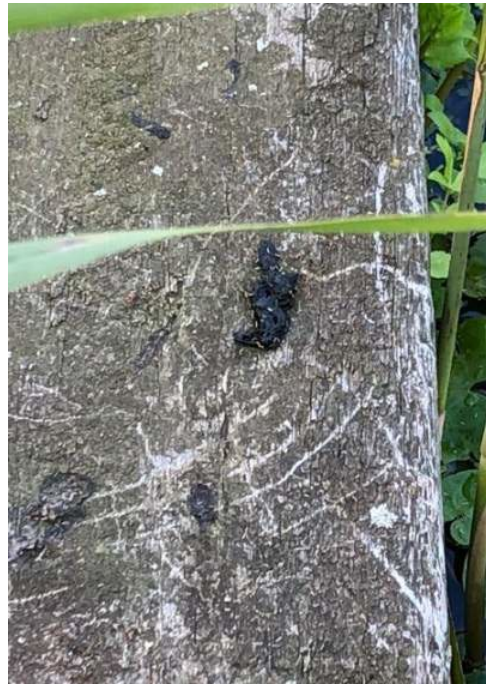
Photograph 14: Spraint on plank crossing waterbody 35

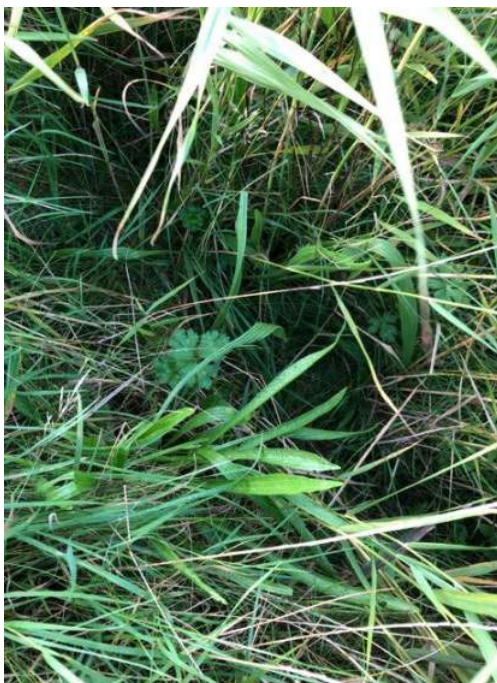
Photograph 15: Likely laying up spot for otter on water's edge, adjacent to pathway into water on waterbody 39

Water body no.	Visit	Date	Otter signs	Water vole signs	Comments
	Late	12/09/2019	-	-	
38	Early	05/06/2019	-	-	
	Late	04/09/2019	-	-	
39	Early	04/06/2019	Spraints	-	Two spraints at northern end of reen. Area adjacent smells like mink. Mammal pathway into water in this location. Mink scat also found where reen meets road.
	Late	12/09/2019	Laying up	-	Likely laying up spot for otter on water's edge at northern end of reen, next to pathway into water.
