Cardiff Parkway Development Ltd
Cardiff Parkway
Geotechnical Desk Study

Issue | 19 December 2017

Job title		Cardiff Parkway		Job number 252199	
Document title		Geotechnical Desk Study		File reference 4-50	
Document ref					
Revision	Date	Filename	Cardiff Parkway Desk Study-Issue.docx		
Issue	19 Dec 2017	Description			
			Prepared by	Checked by	Approved by
		Name	Edward Boss	Tim Wilkinson	Dan Raynor
		Signature

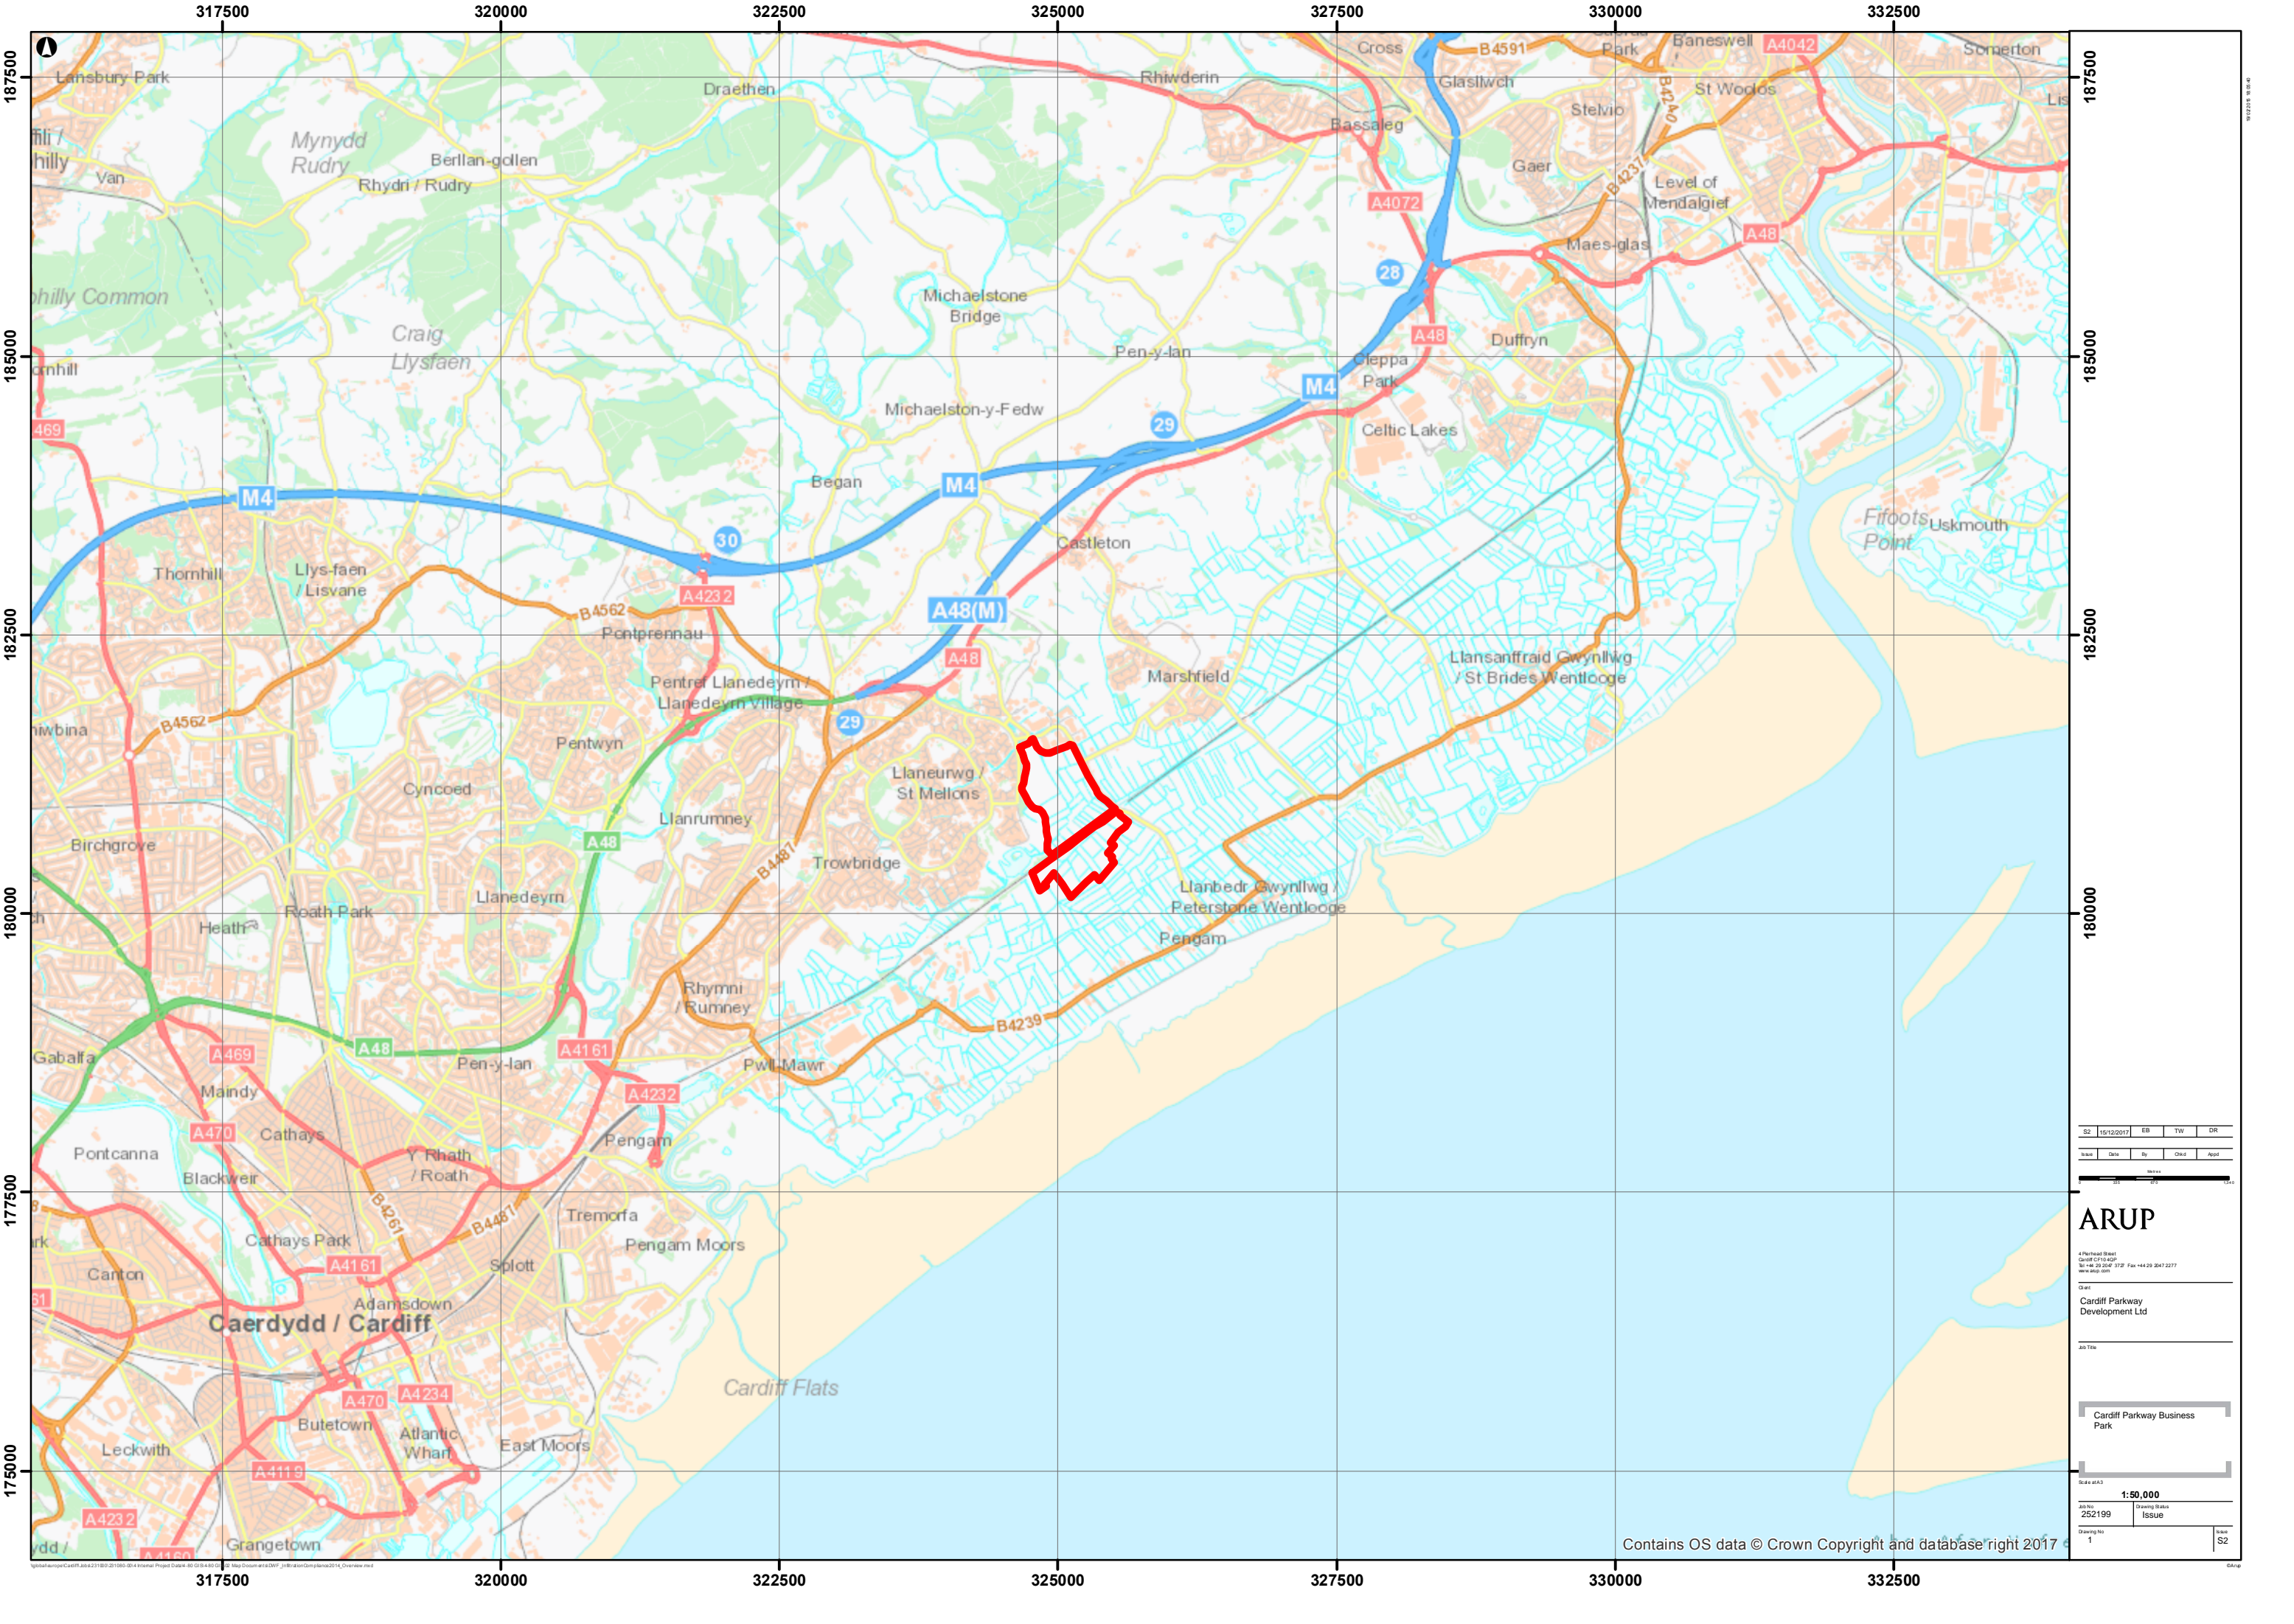
1:50,000	
Job No 252199	Drawing Status Issue
Drawing No 1	Issue S2

Figure 1 Site Location

The site is located approximately 7km east of Cardiff, near St Mellons, refer to **Figure 1**. The Bristol to South Wales main line railway runs northeast to southwest bisecting the site into a northern area and southern areas, as shown on **Figure 2**. Both the northern and southern site areas are currently occupied by fields with a network of drainage channels (reens).

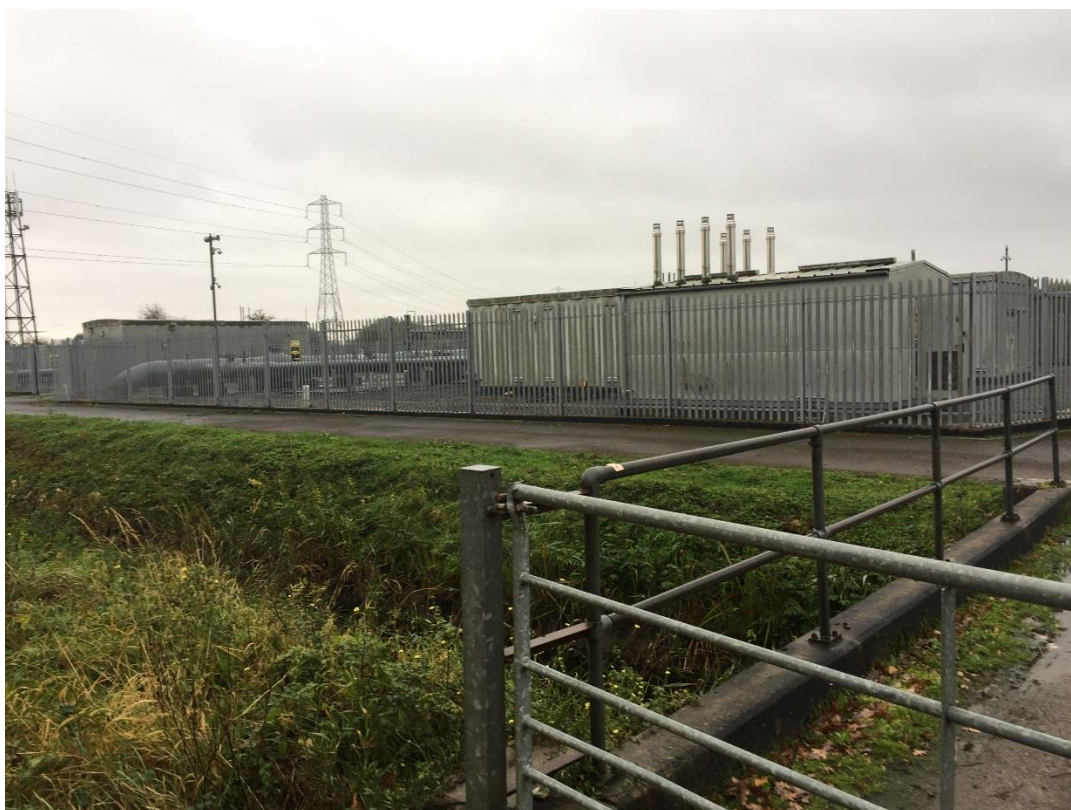
Photograph 5 – The gas governor from Heol Las, looking south

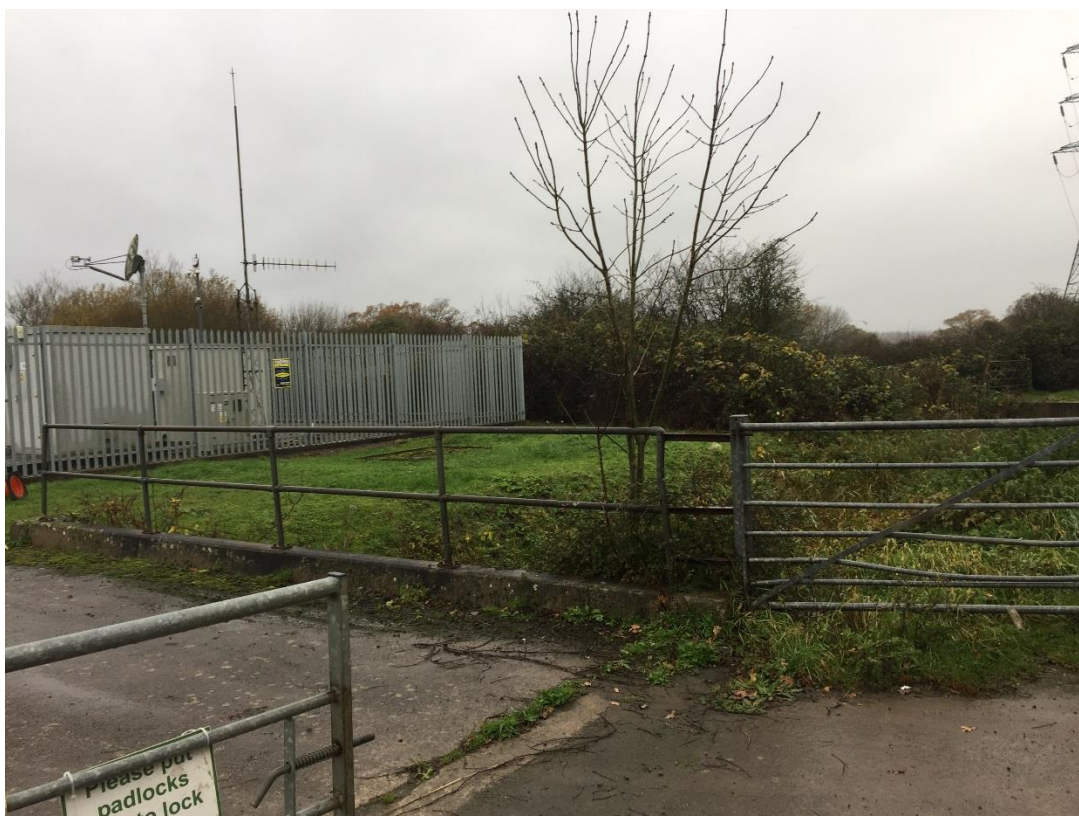
Photograph 6 – The gas governor from Heol Las, looking west

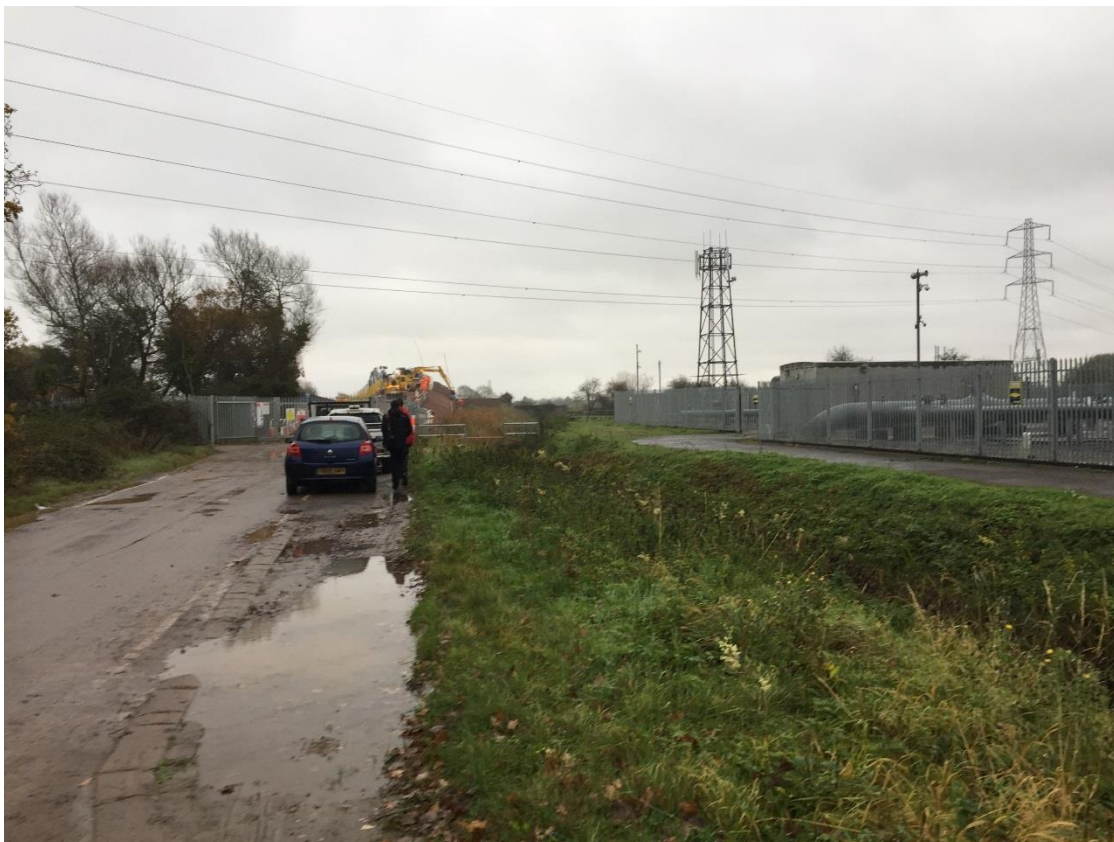
Photograph 8 – Looking southeast from next to the gas governor on Heol Las

The reconstruction of the Heol Las overbridge was underway during the visit, and the southern site area was not accessed (Photograph 8, Appendix A). From review of aerial images, the southern site area is anticipated to comprise fields of a similar nature to the fields in the northern site area.

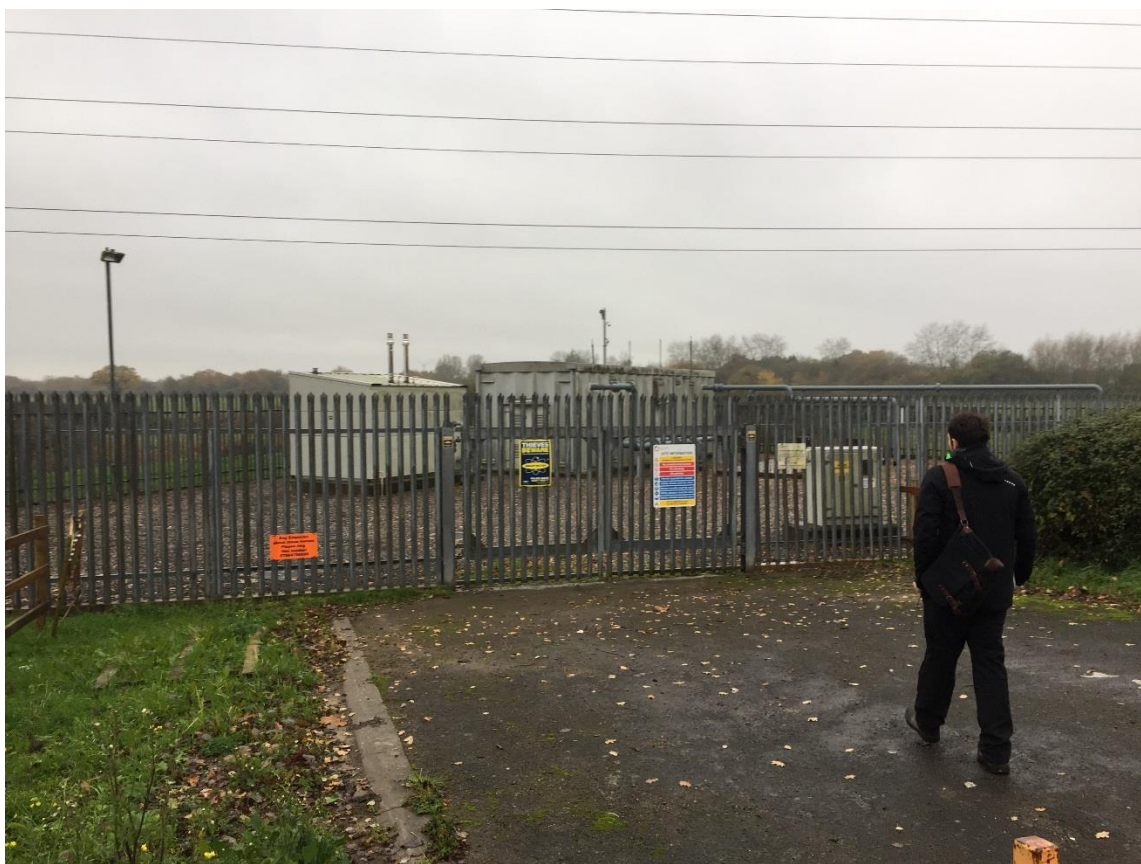
Photograph 12 - Looking southwest from Cobol Road at the gas governor

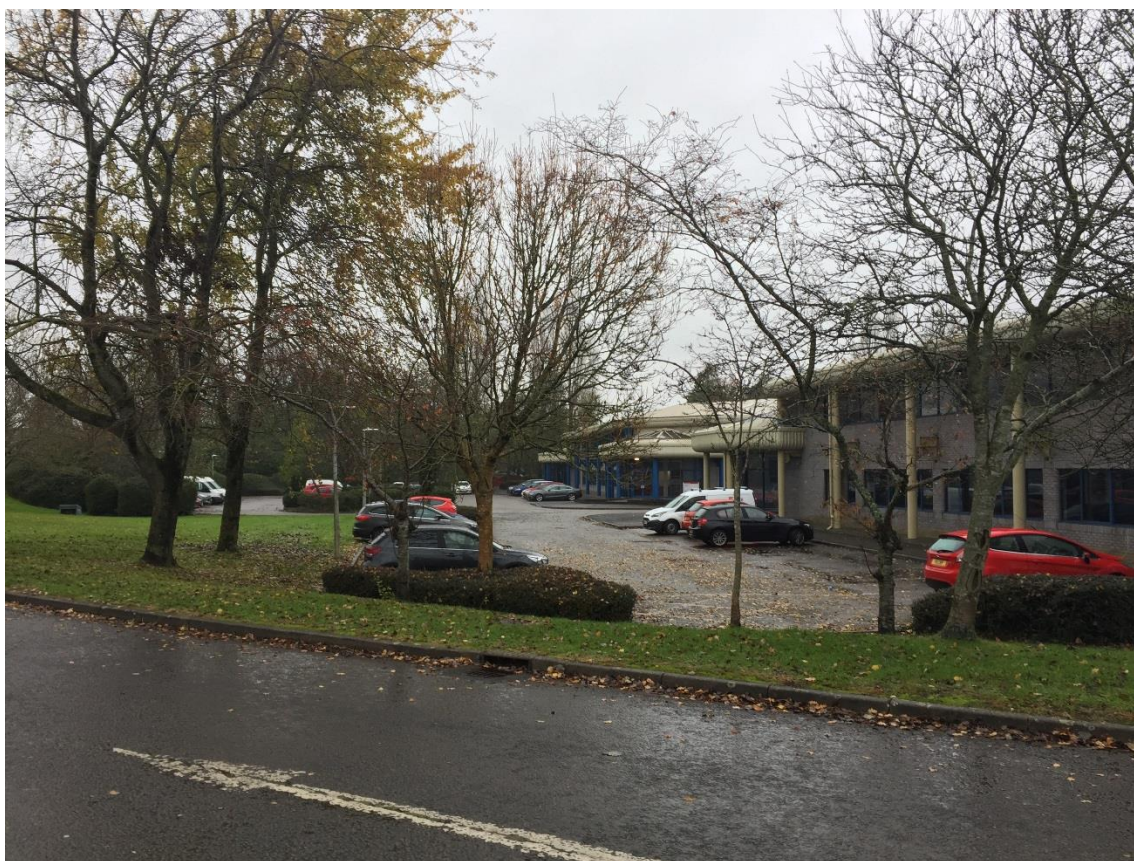
Photograph 13 - Looking north from Cobol Road at the existing business park

There was no evidence identified of any settlement for the buildings within the existing St Mellons Business Park to the north of proposed site, which appears to have been constructed at or close to the original ground level. Very minor settlement and cracking was identified in the pavement on the south-western corner of the southern building in the business park, which may have been caused by the pavement settling a few millimetres where the fill has been locally placed to provide ramped access to the building (Photograph 14, Appendix A).

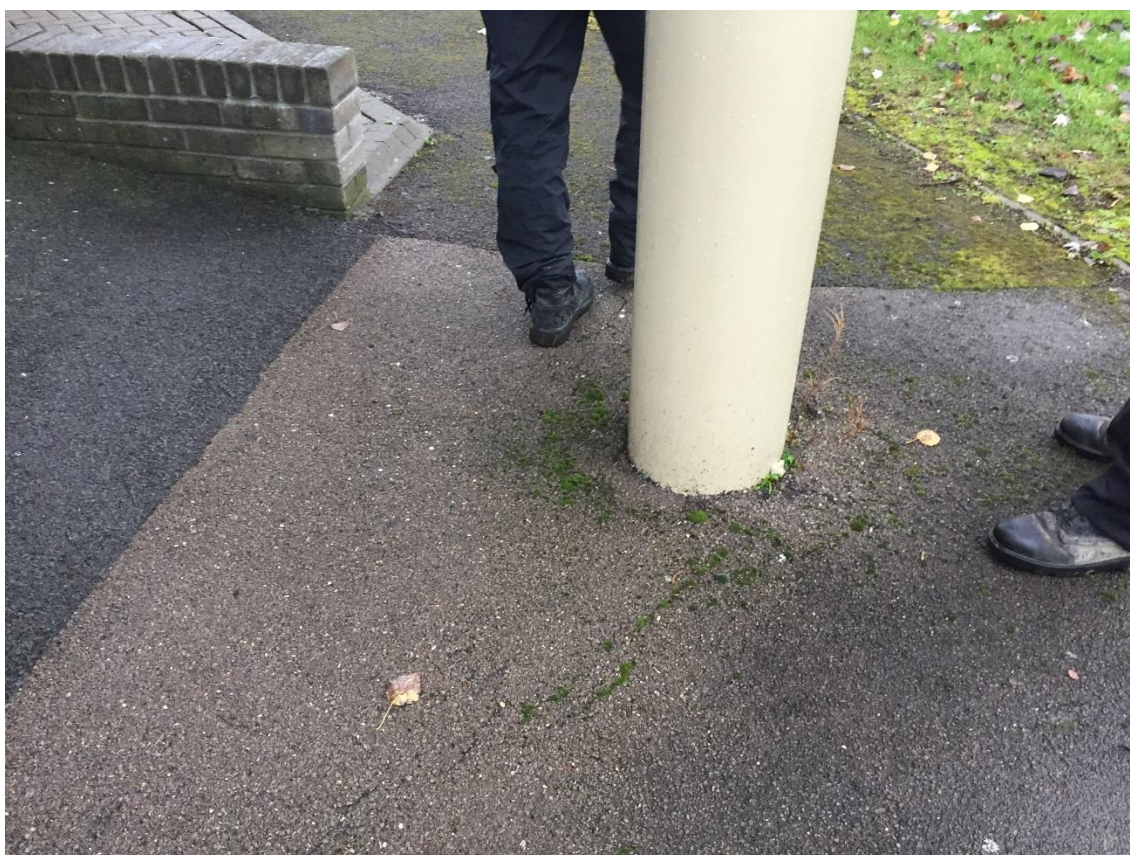
Photograph 14 – Looking at the southern corner of a building in the existing business park. Sign of possible slight settlement in pavement.
