Cardiff Parkway Developments Ltd
Cardiff Parkway
Ground Investigation Report

Issue | 19 November 2019

Job number 252199

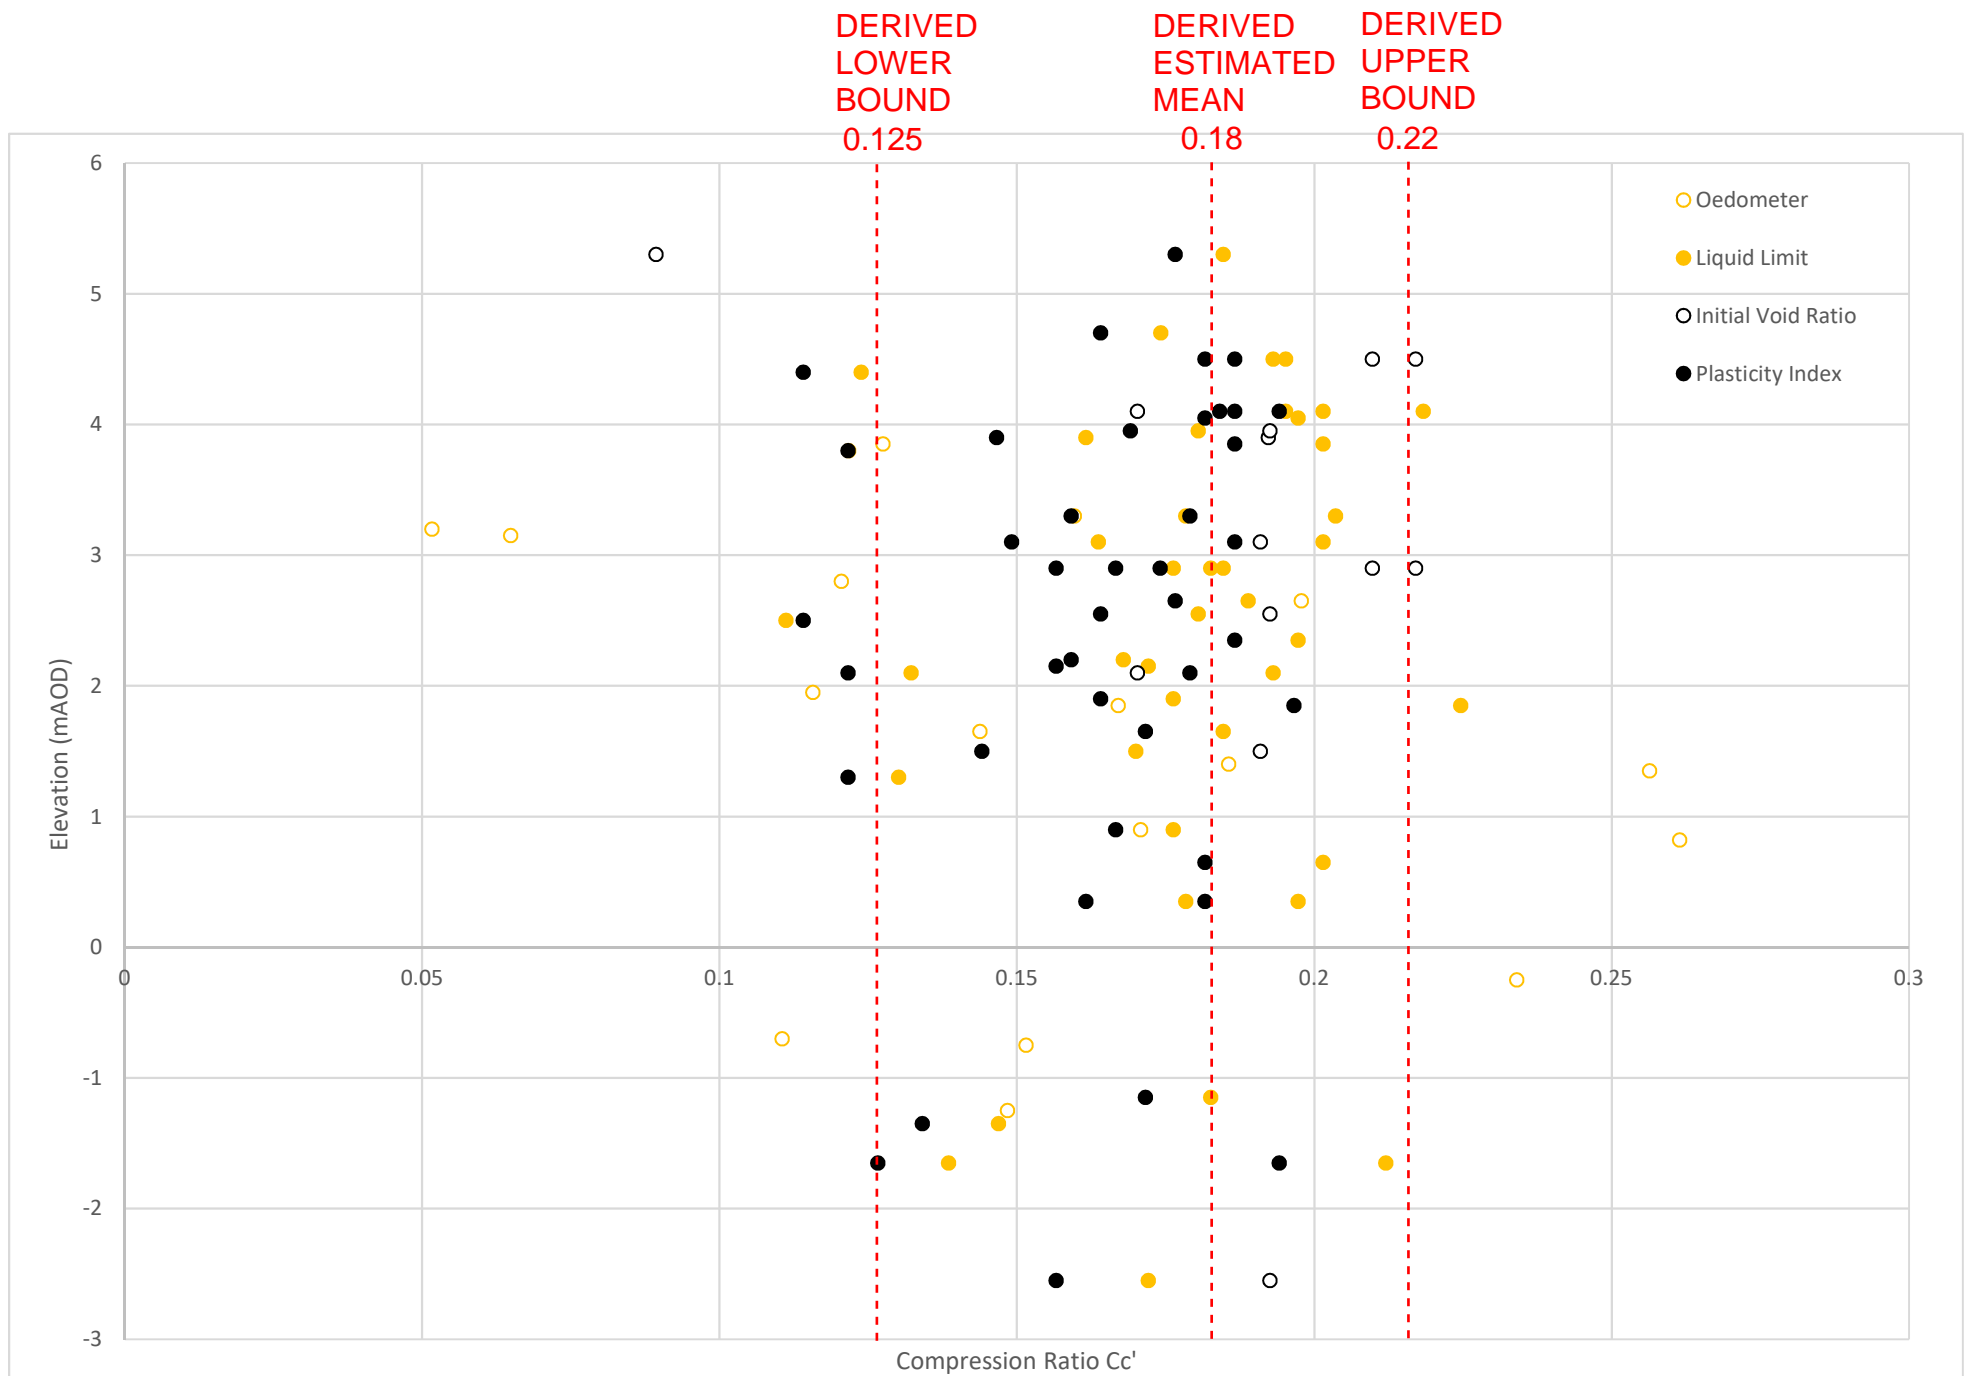
CARDIFF PARKWAY
Cc' with ELEVATION
TFD-CLAY 252199 - Plot B.2.9

- A derived C'_c value is equal to 0.157 across from the available Oedometer tests undertaken in the clay.
- The initial void ratio for the above correlations was found using the Oedometer plots. If no void ratio was available for the deposit, the correlation was not undertaken. The initial void ratio for the clay ranged from 0.415 to 2.482. The derived value for C'_c was equal to 0.221.
- Using the liquid limit, a value of C'_c equal to 0.179 was calculated. Whilst using the plasticity index a derived value of 0.165 was derived.
- The C'_c values obtained from the oedometer plots and the above correlations have been plotted with elevation, in Plot B2.9. An upper and lower bound can be suggested between 0.22 to 0.125 respectively. An estimated derived value for the compression ratio C'_c of 0.18 is inferred.

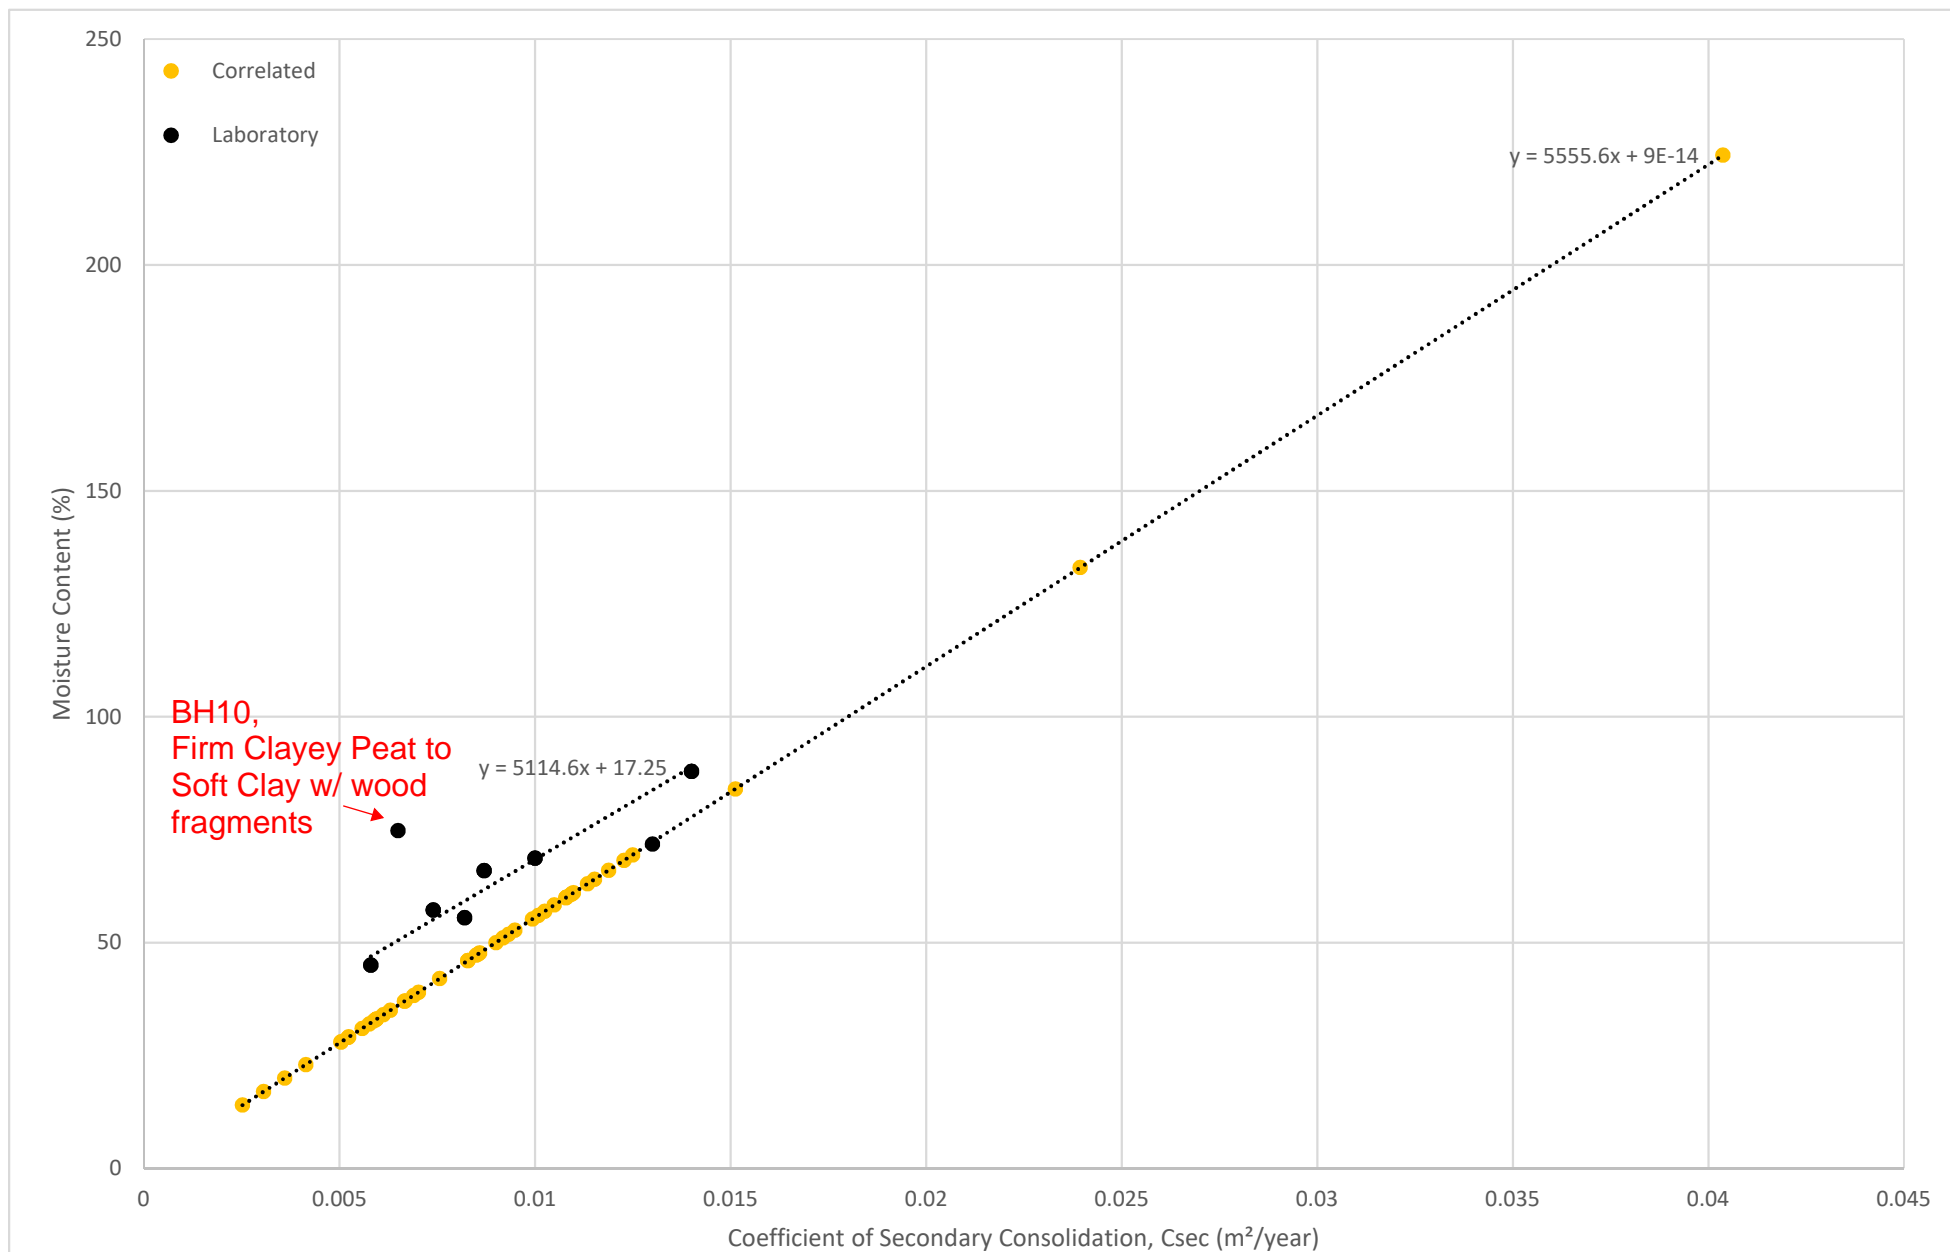
CARDIFF PARKWAY
Csec with MOISTURE CONTENT
TFD-CLAY
252199 - Plot C.2.18

A plot of the coefficient of secondary consolidation with moisture content is presented in the Plot B2.18. It is noted that the results obtained for laboratory oedometer testing's exhibit a greater moisture content per C_{sec} unit than the derived correlated values.

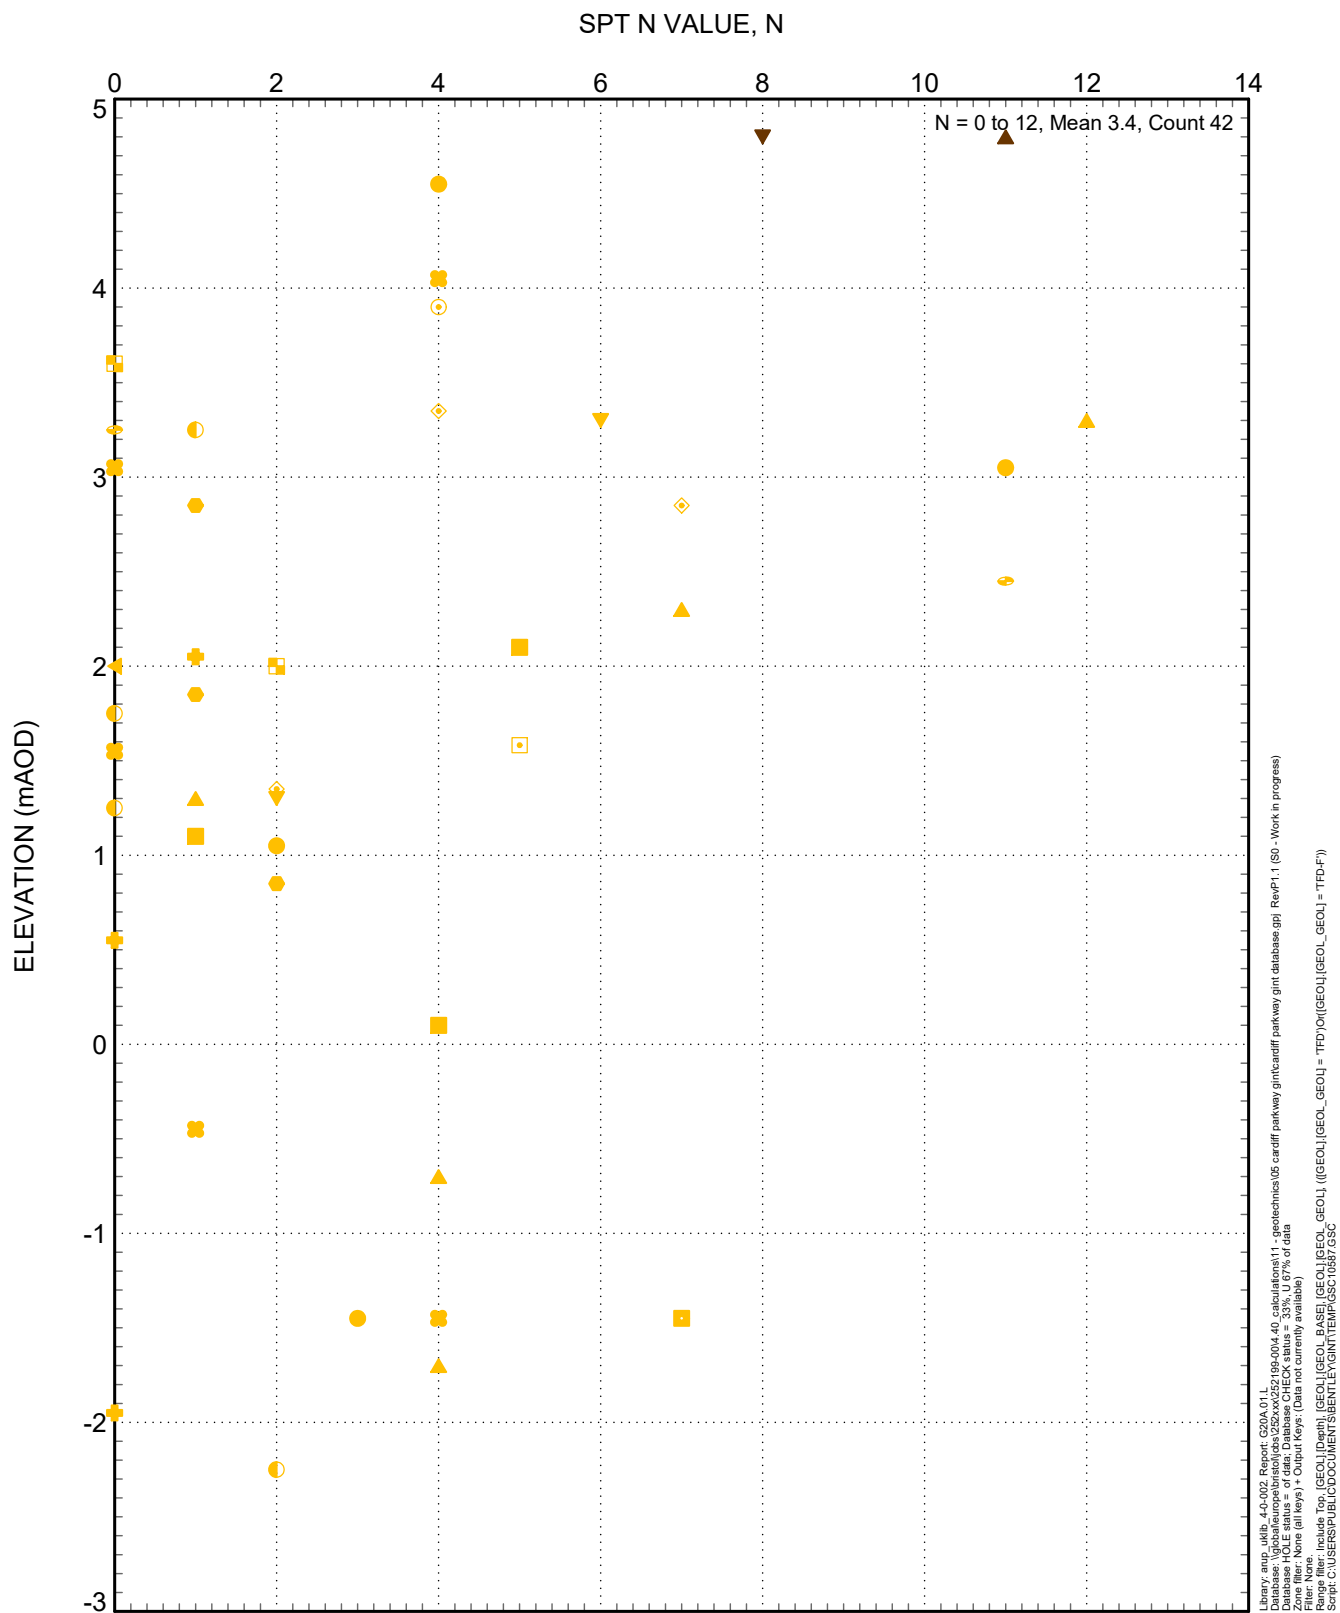
252199 - Plot B.2.19

Forty-four tests were undertaken on the Tidal Flat Deposit clay across 15 exploratory holes. The following can be observed (Plot B2.19):

Where SPT N VALUES = 0 the materials are typically described as:
 "Pocket of Peat"
 "Roof fragments"
 "Very soft Clay"

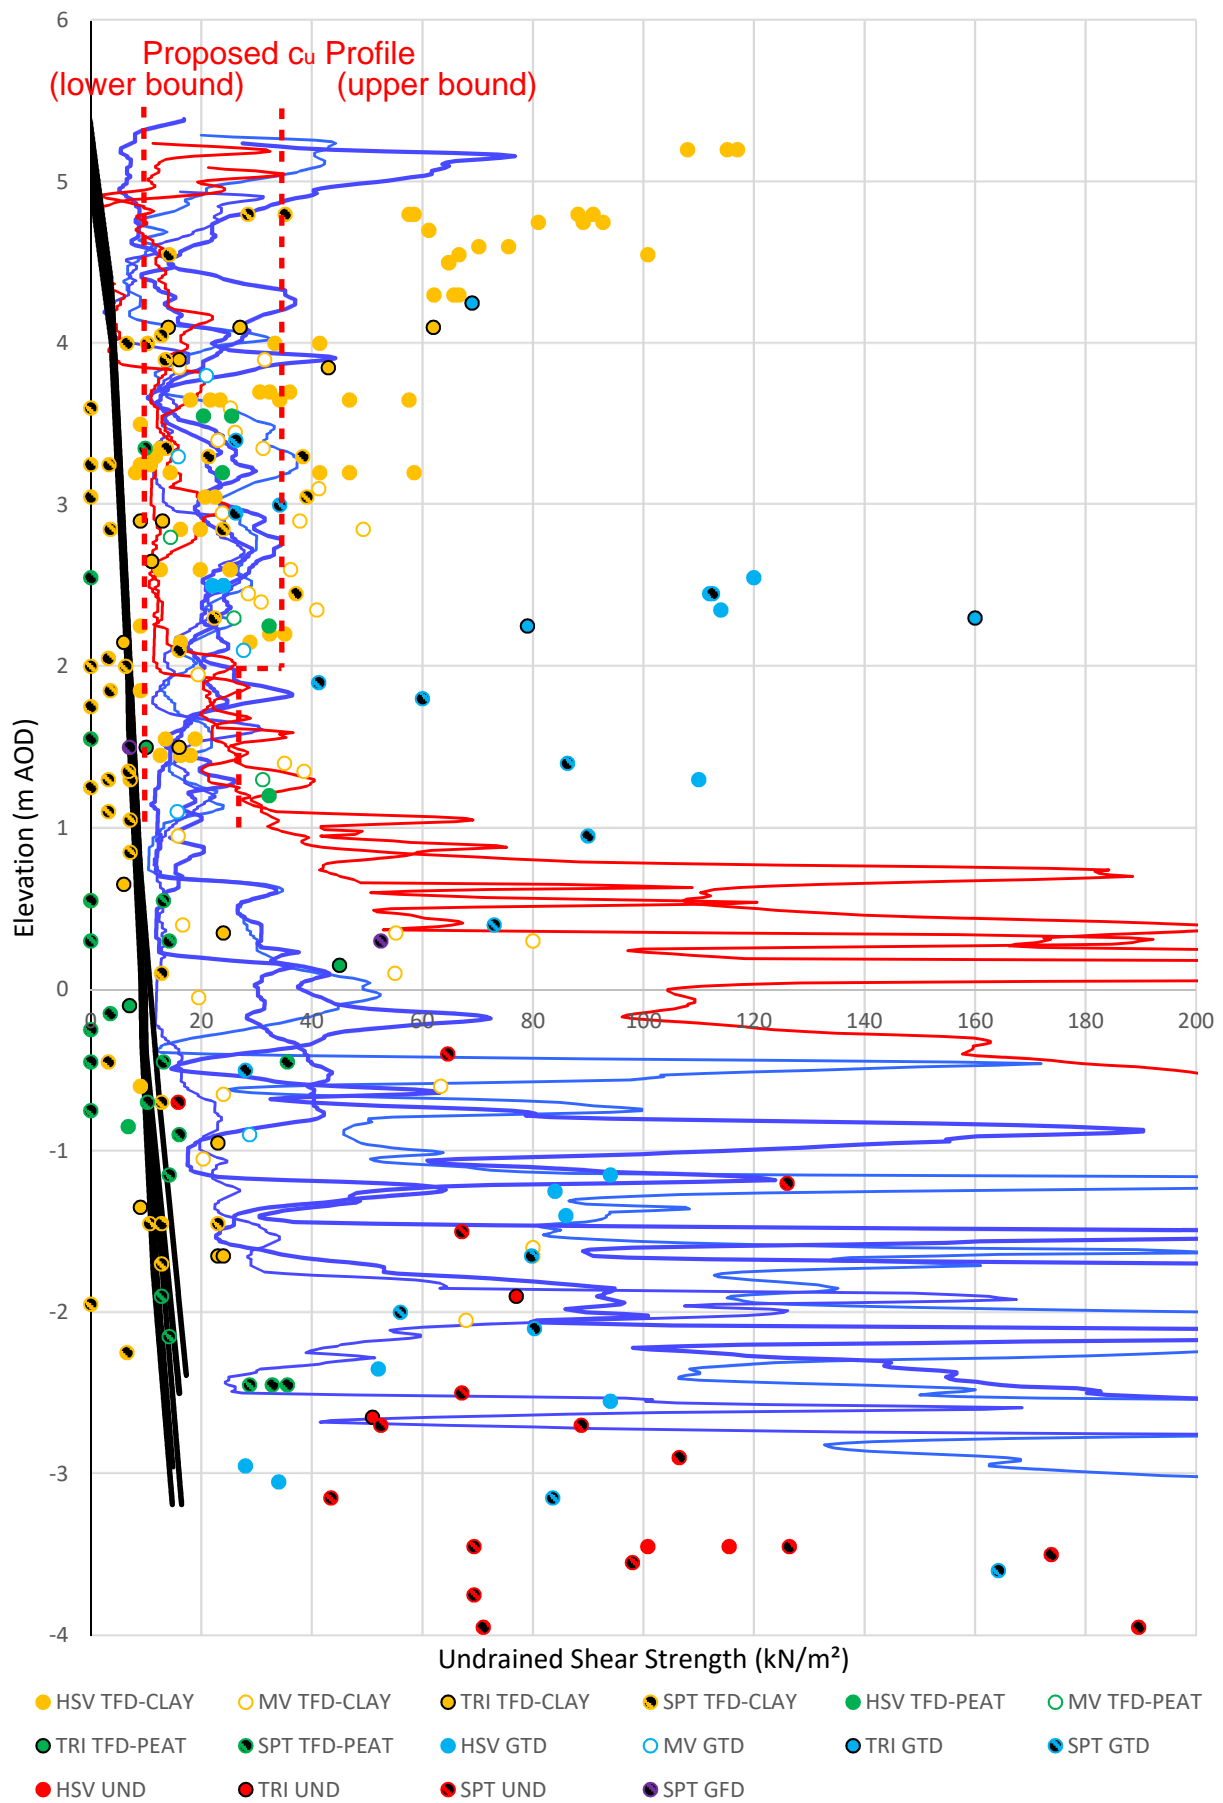
252199 - Plot B.2.20

The following results for undrained shear strength were observed from the hand vane tests:

- Tests conducted between 5.5mAOD to 4mAOD ranged from corrected values of 117.0 kN/m^2 to 58 kN/m^2 . An estimated mean value for this elevation range is 70 kN/m^2 . It is noted all tests conducted within this elevation range are designated as the desiccated crust.
- The remaining tests undertaken below 4mAOD ranged from 59 kN/m^2 to 8 kN/m^2 . With a mean value derived as 24 kN/m^2 .

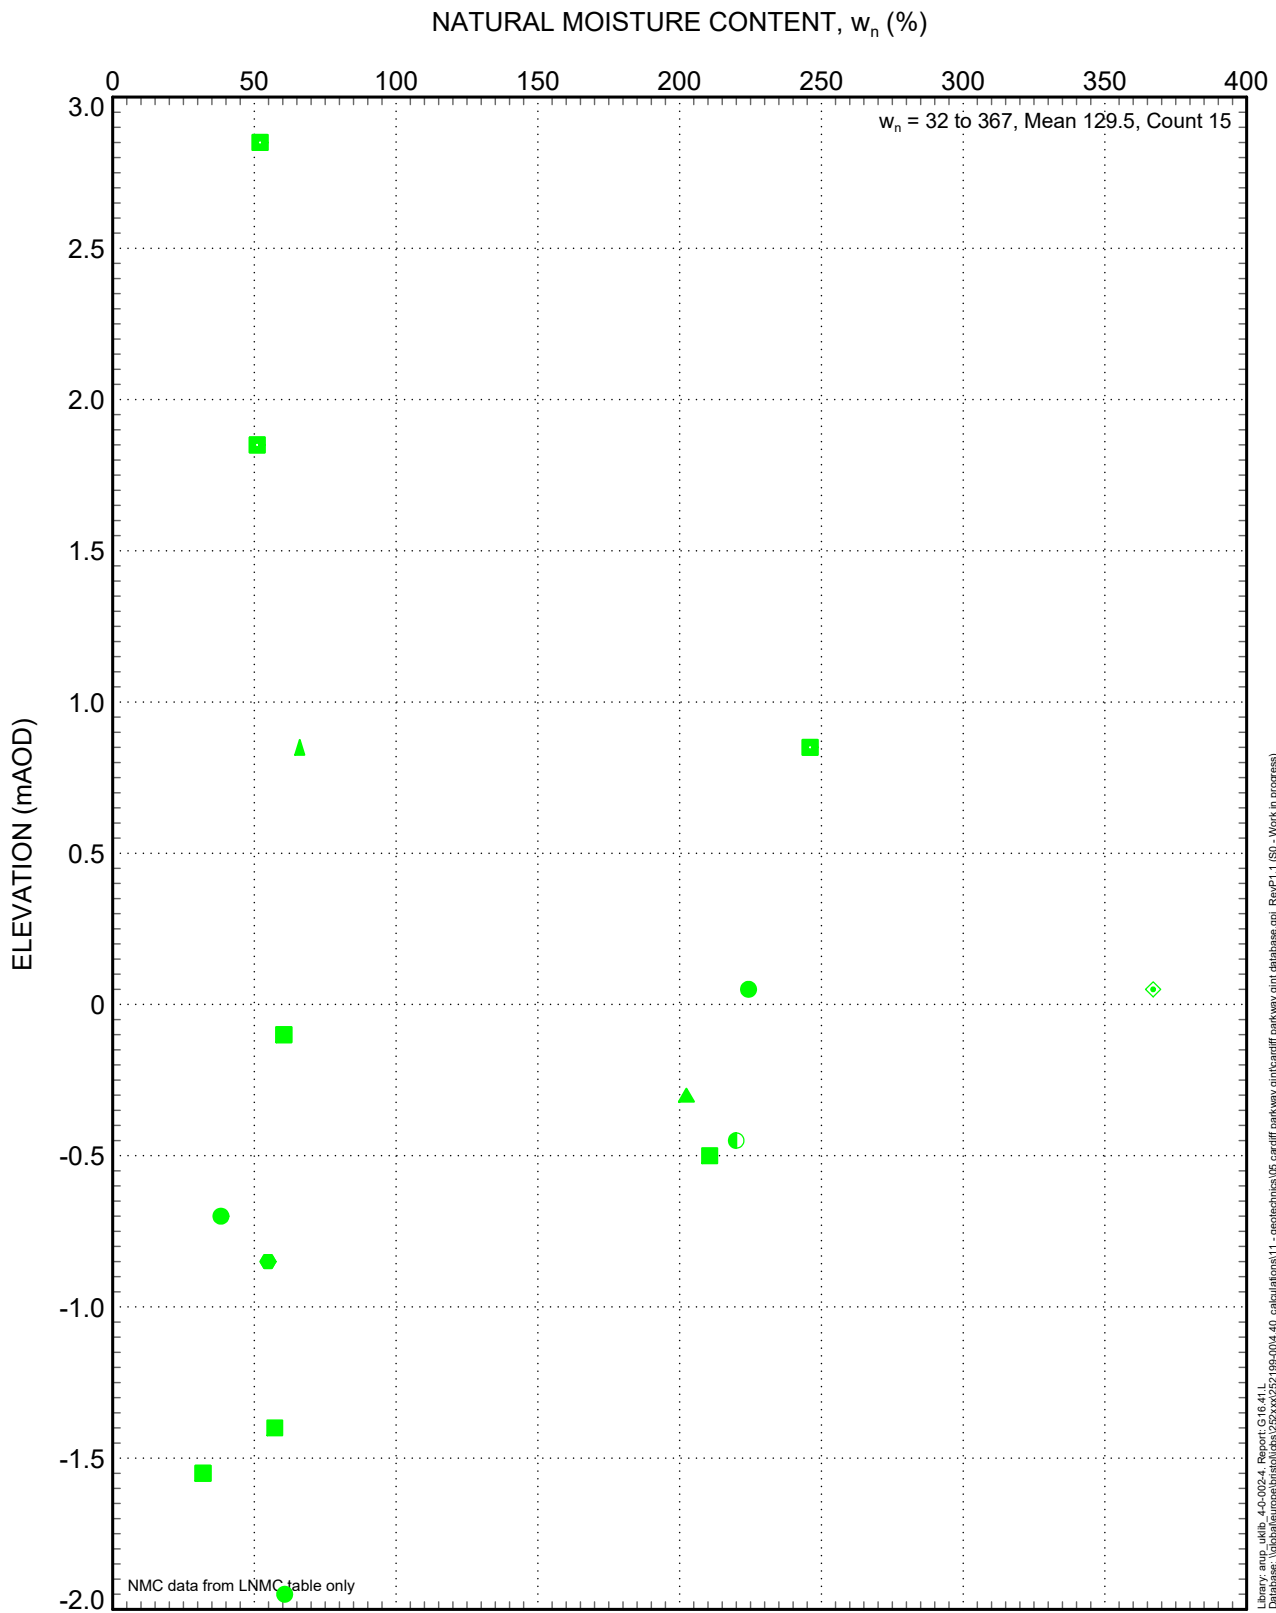
252199 - Plot B.3.1

The natural moisture content for the TFD peat varies from 32% to 367% with fifteen tests conducted in the material. A mean value for the natural moisture content is derived as 200%. The natural moisture content of the peat varies dramatically. There is potential for low moisture content to be representative of the clay due to the nature of the peat's thin strata thickness. Shown in Plot B3.1.

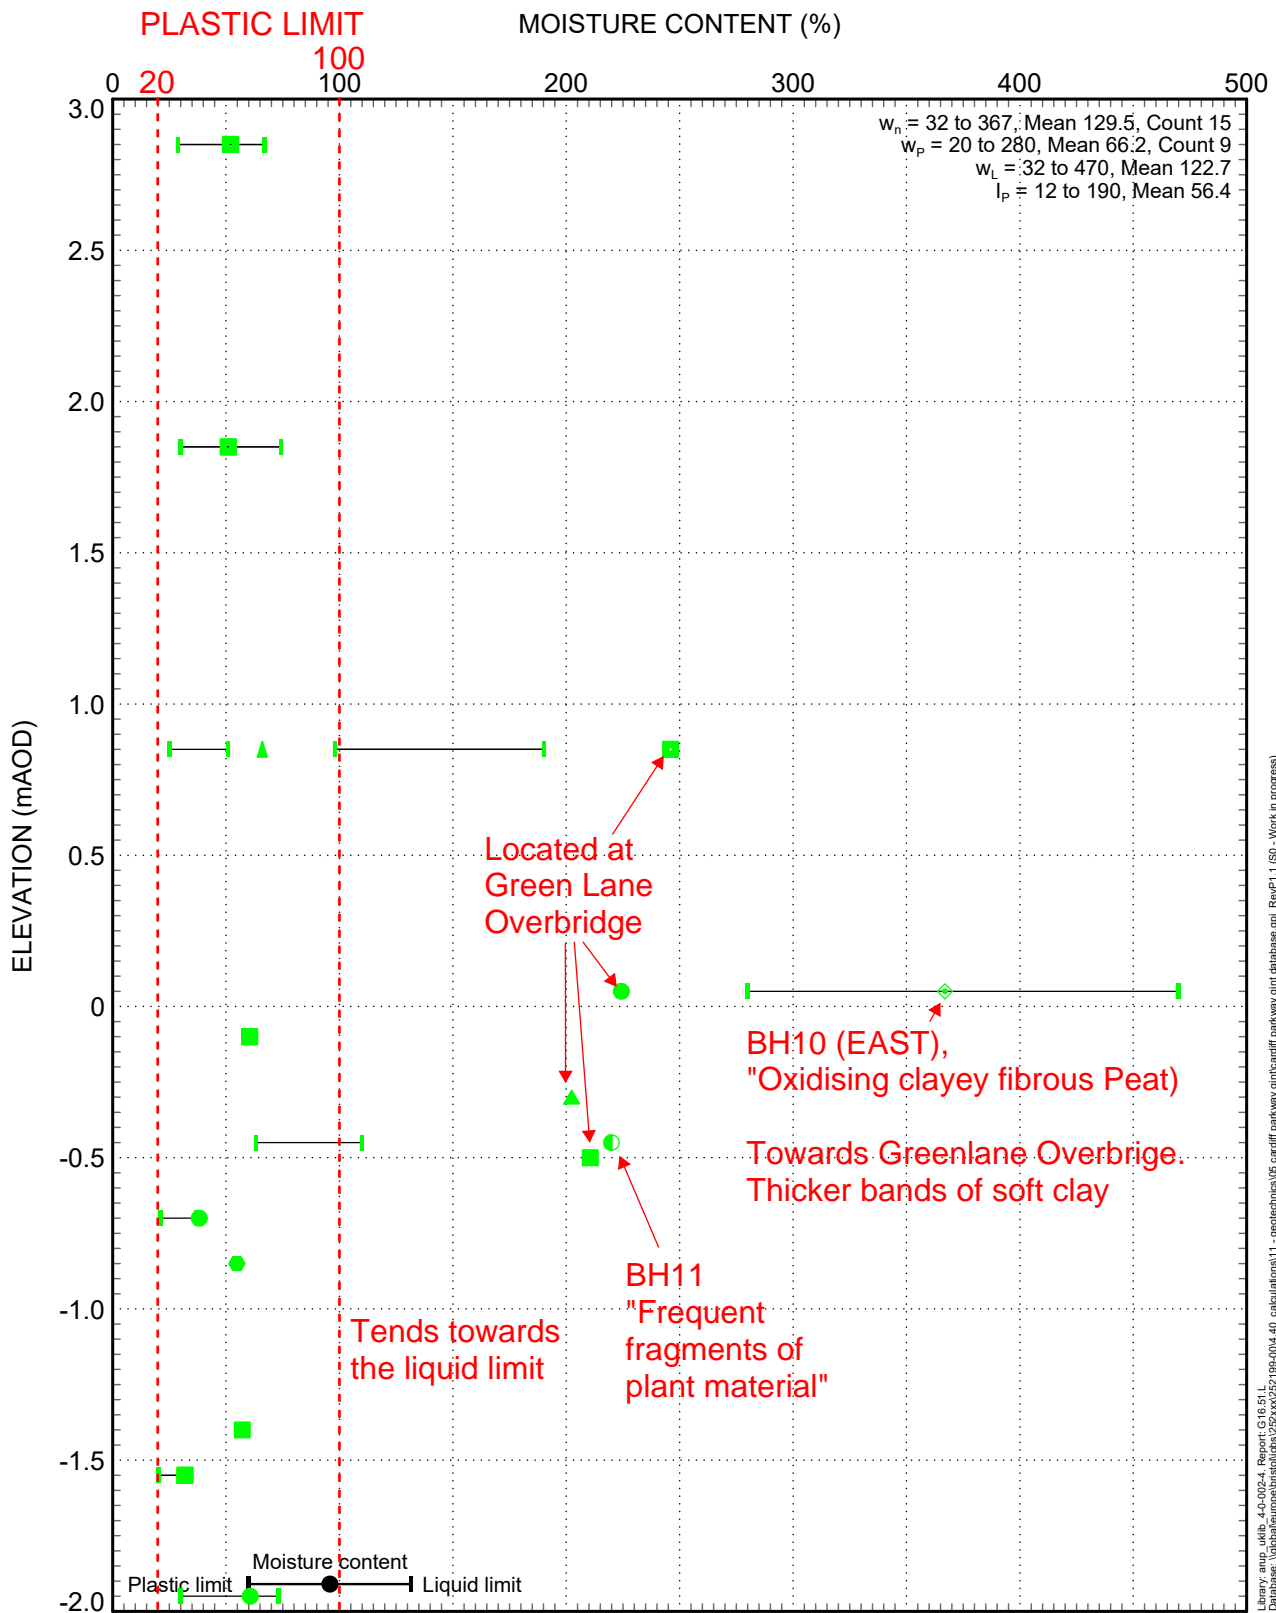
252199 - Plot B.3.2

The natural moisture content of the deposit generally tends towards the liquid limit at varying elevations, shown in Plot B3.2.

BH10 exhibits a moisture content of 367, with a plastic and liquid limit value of 280 and 470 respectively. The test in BH10 was undertaken in what was described as an oxidising clayey fibrous peat, this could be indicative to these high values.

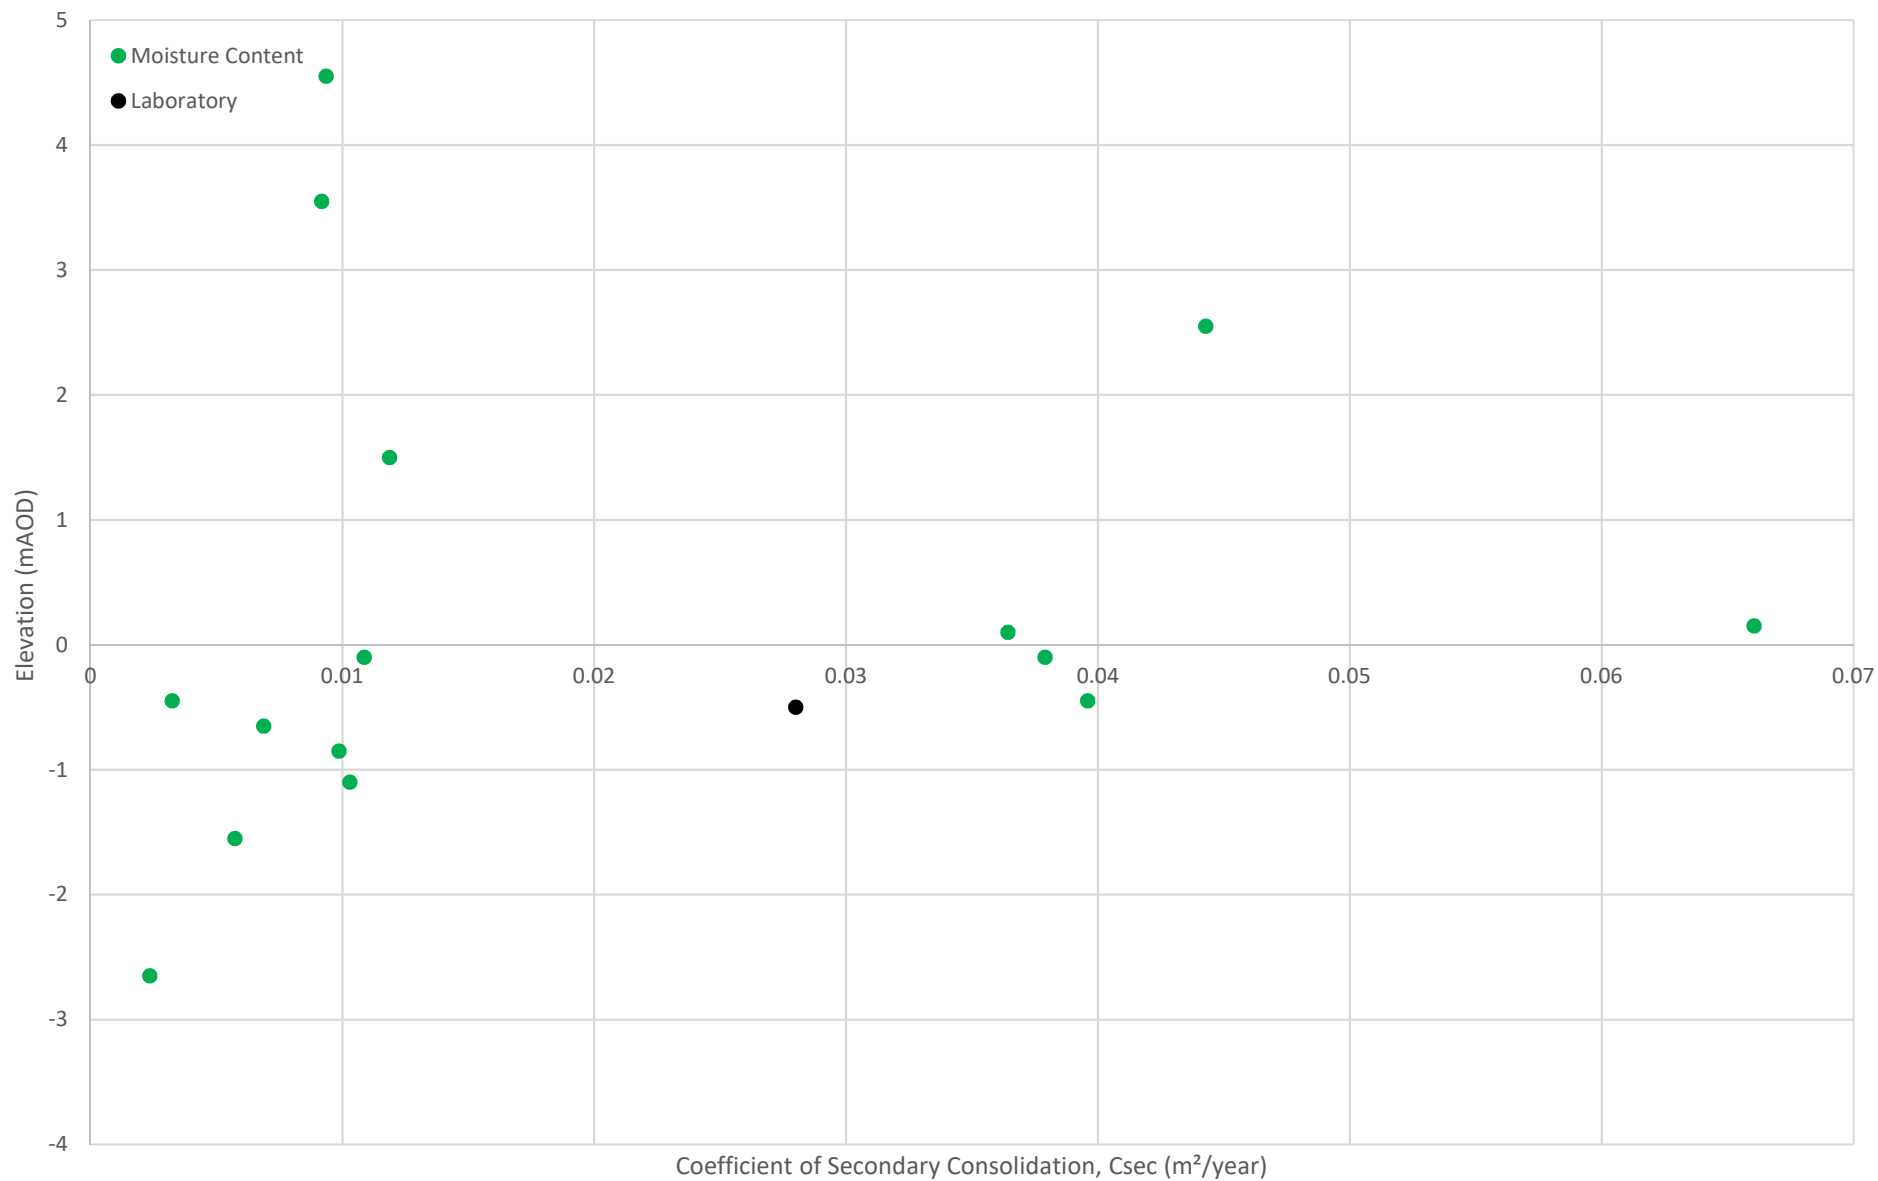
252199 - Plot B.3.12

A plot of the coefficient of secondary consolidation with moisture content is presented in Plot B3.12. It is noted that the result obtained from laboratory oedometer testing exhibits a greater moisture content per C_{sec} unit than the derived correlated values.

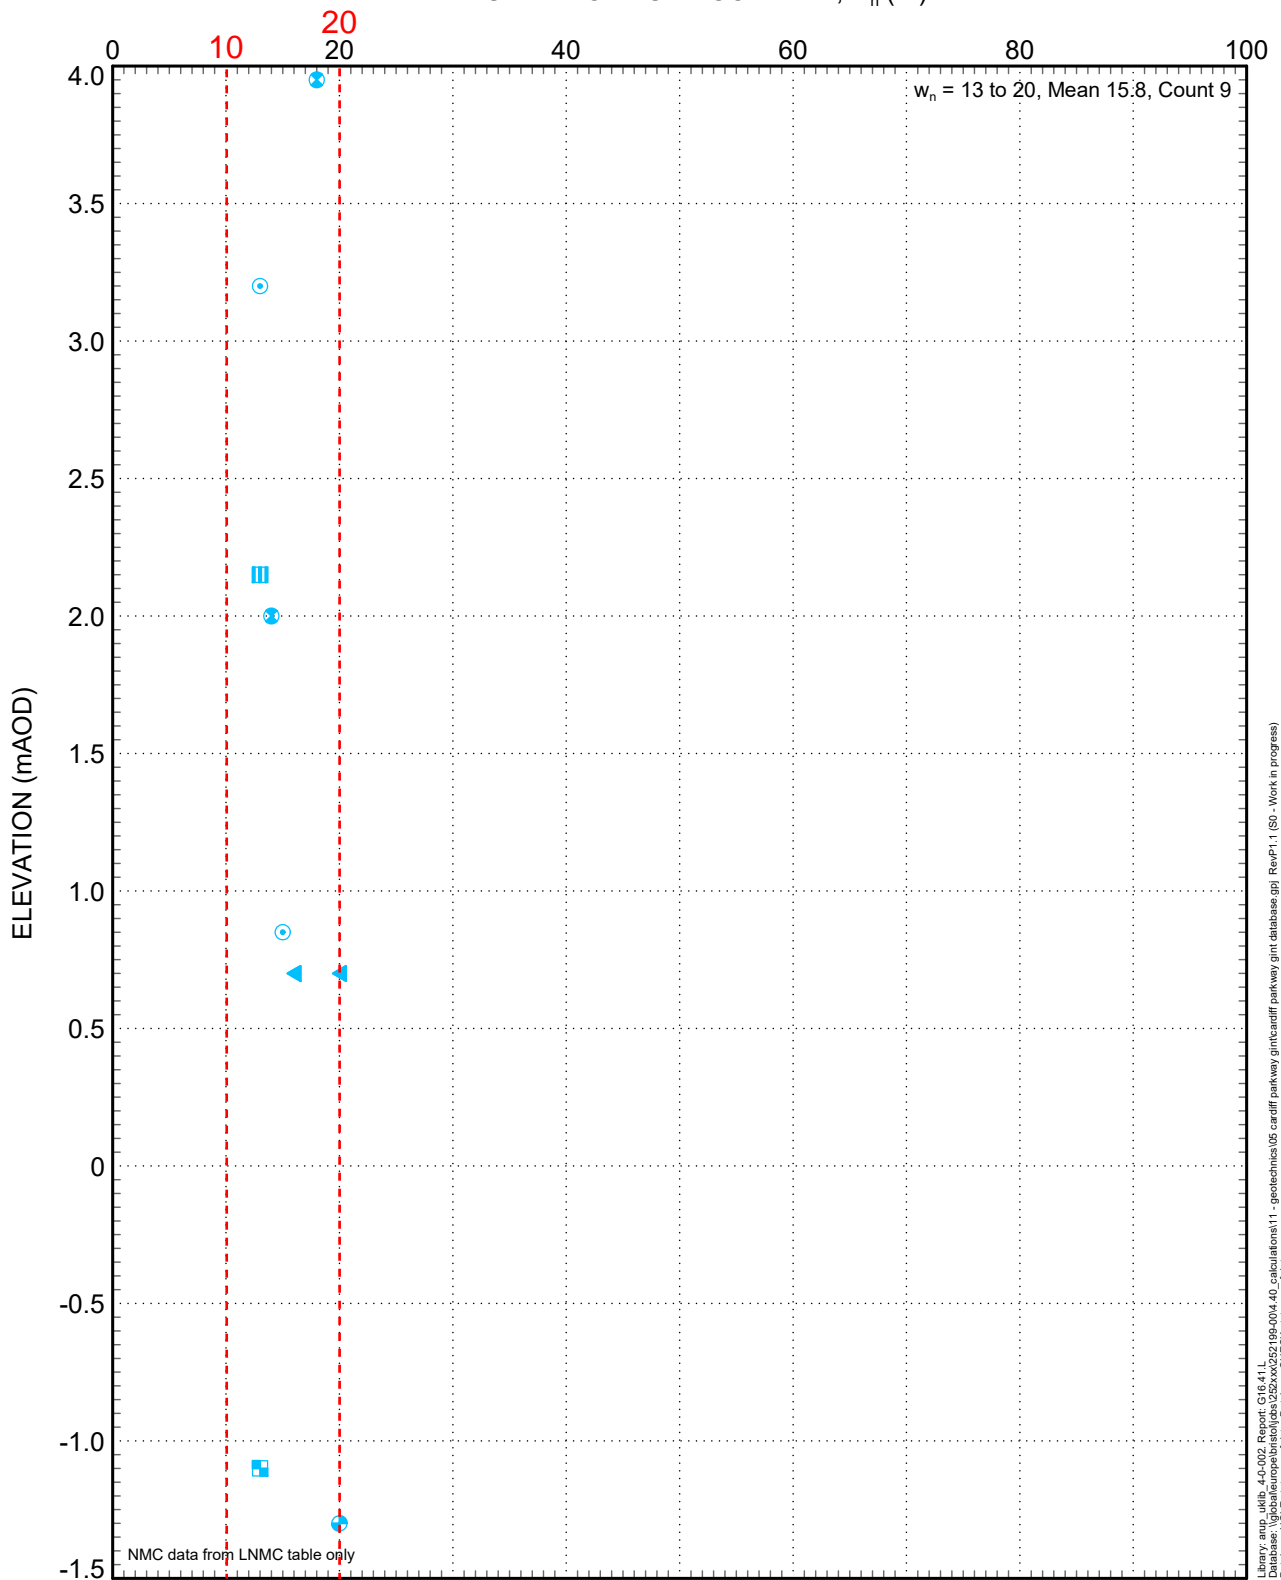
Natural moisture content with elevation is presented in the Plot B4.1. The natural moisture content for the GTD varied from 10 to 20% with nine tests conducted in the material. A derived mean value for the natural moisture content is calculated as 16%.

Summary statistics: $w_n = 13$ to 20 , Mean 15.8 , Count 9
Database: \\global\project\cardiff\252199\004\40_calculations\11 - geotechnics\05 cardiff parkway gint database.gpi RevP1.1 (SD - Work in progress)
Database HOLE status = of data, Database CHECK status = of data
Zone filter: None (all keys) - Output Keys: (Data not currently available)
Range filter: Include Top, [GEOLOGY][Depth], [GEOLOGY][Base], [GEOLOGY][GEOLOGY] = 'GTD' or [GEOLOGY][GEOLOGY] = 'GFD'
Script: C:\USERS\PUBLIC\DOCUMENTS\BENTLEY\GINT\TEMP\GSC00592.GSC
